Subject: Menangle Quarry - 2023 Annual Review

MENANGLE SAND AND SOIL ANNUAL REVIEW (Condition D9)

Benedict Sands Menangle (LEC 2018/342158)

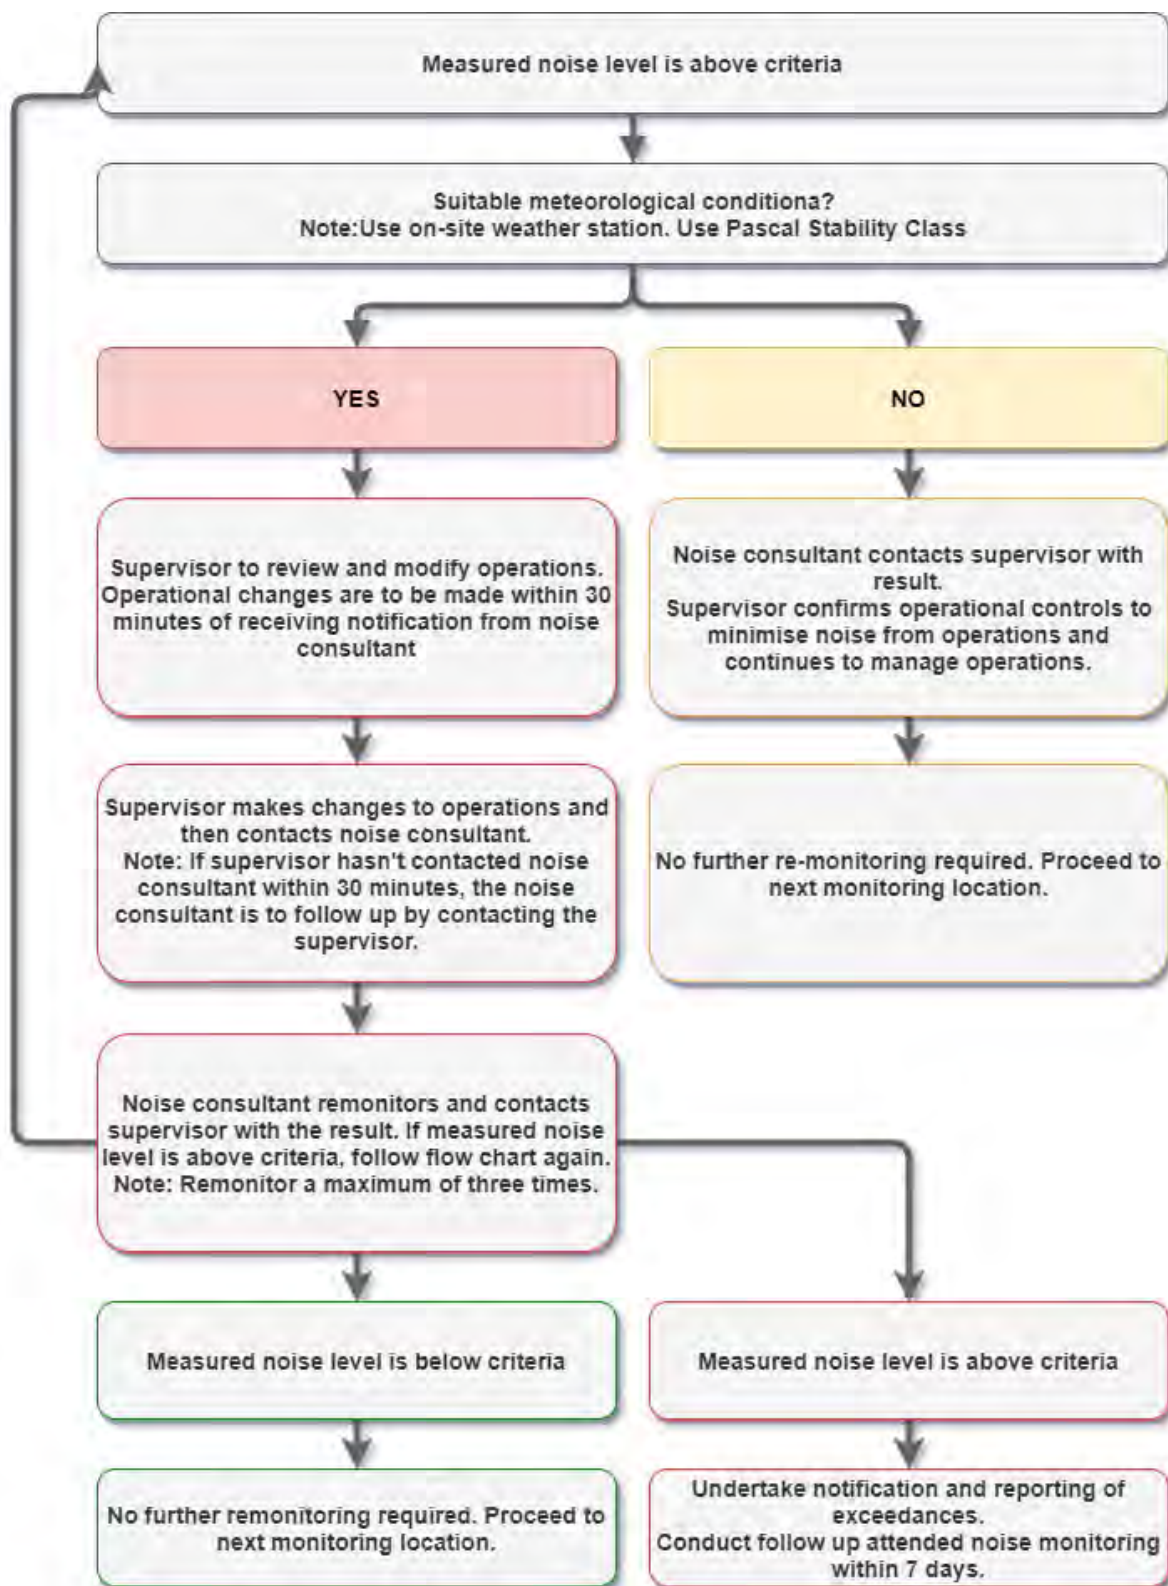
If attended noise monitoring identifies that the noise criteria as per Table 3.1 have been exceeded, the person conducting the attended noise monitoring will follow the noise exceedance protocol presented in Figure 5.1.

Figure 5.1 Noise exceedance protocol

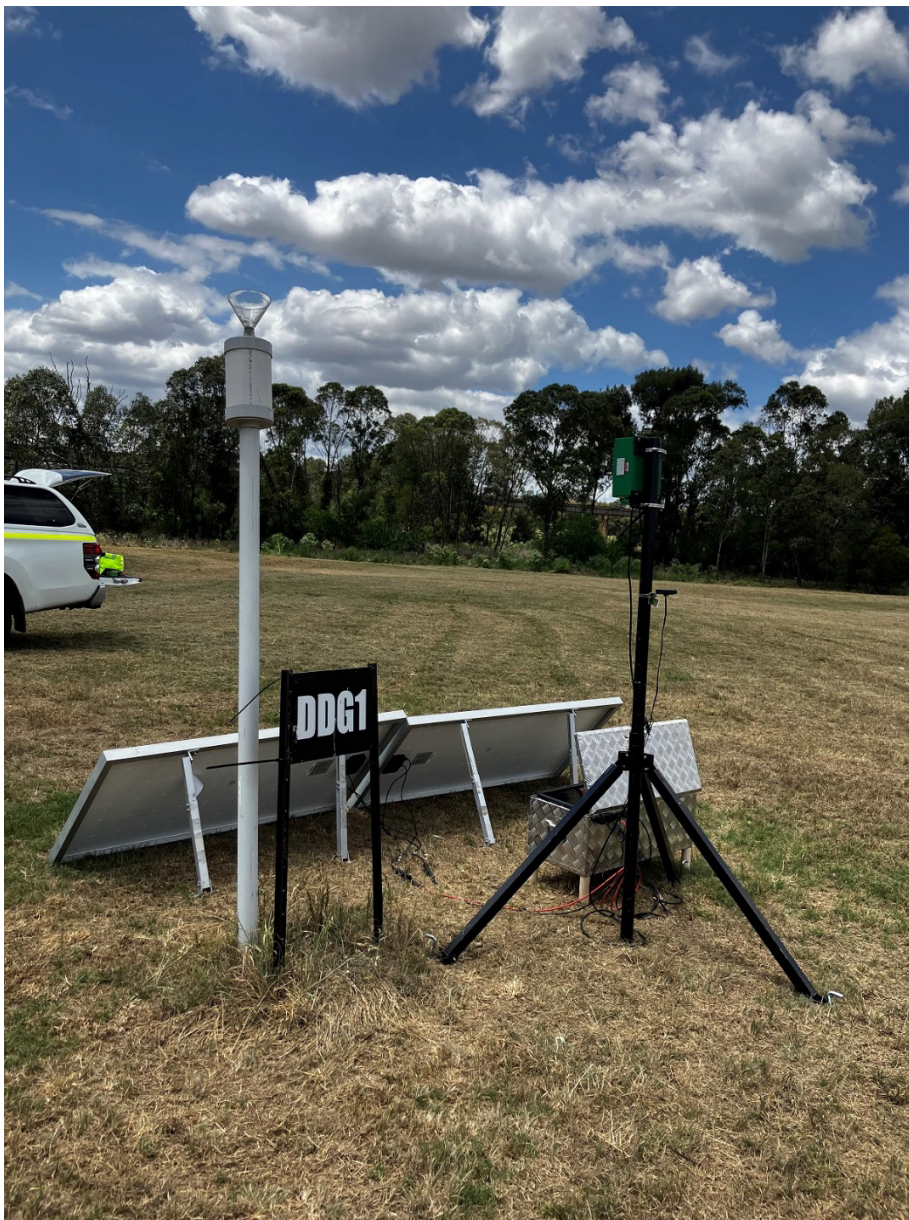
Photograph 3.1 AQM01 monitoring location – co-located with DDG1

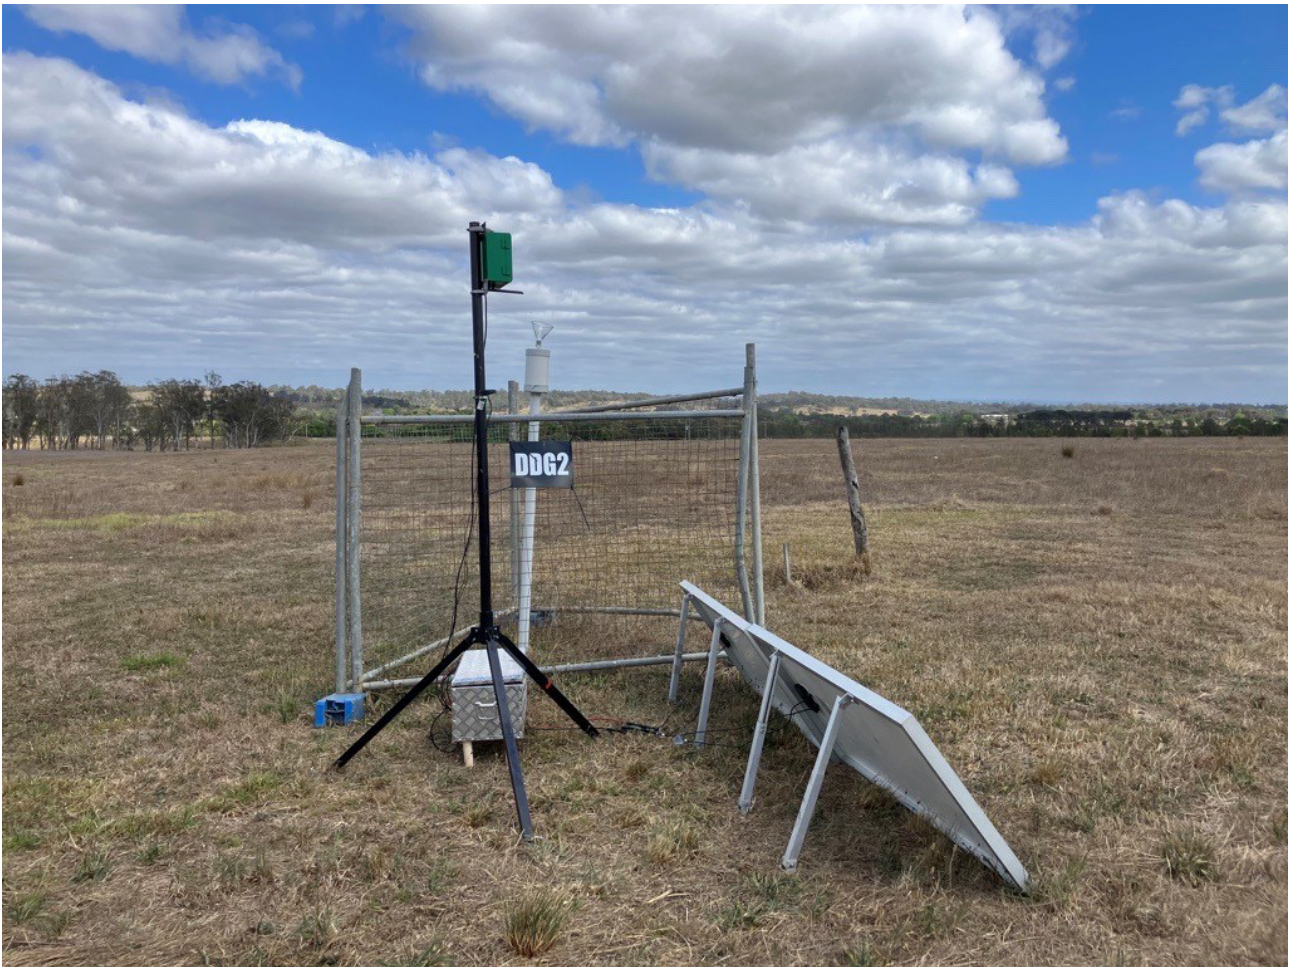
Photograph 3.2 **AQM02 monitoring location – co-located with DDG2**

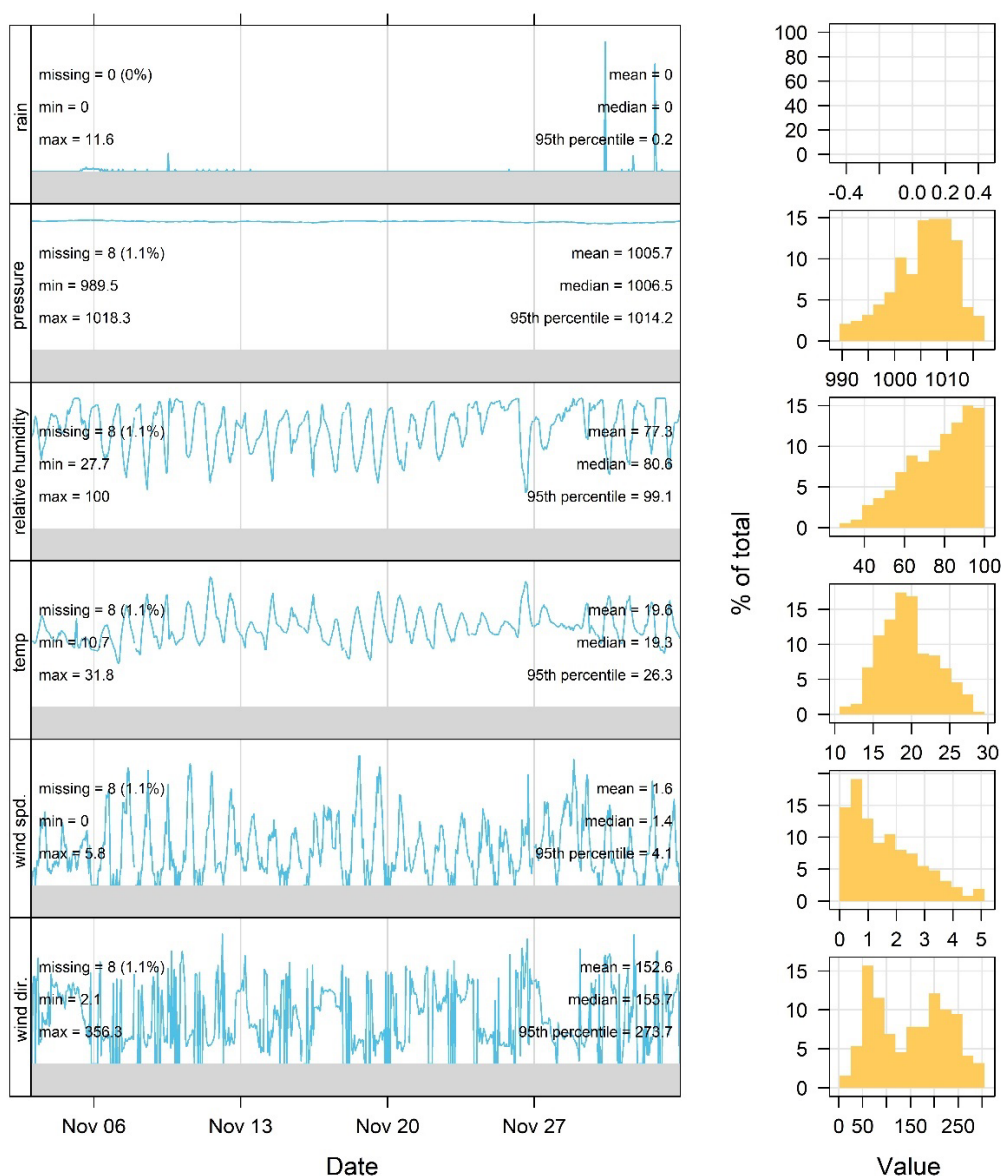
An overview of the continuous data from the Menangle AWS for Period 1 and Period 2 are provided in Figure 4.1 and Figure 4.2 respectively. The panel on the left shows the time series of 1-hour values for each parameter, with the grey bars indicating the presence of data and any red bars indicating missing data. Some summary statistics for the reporting period are also give, including the mean median, 95th percentile, minimum, maximum and number of missing points. The panel on the right shows the frequency distribution of the values for each parameter.

Figure 4.1 Meteorological data summary – Menangle AWS – Period 1

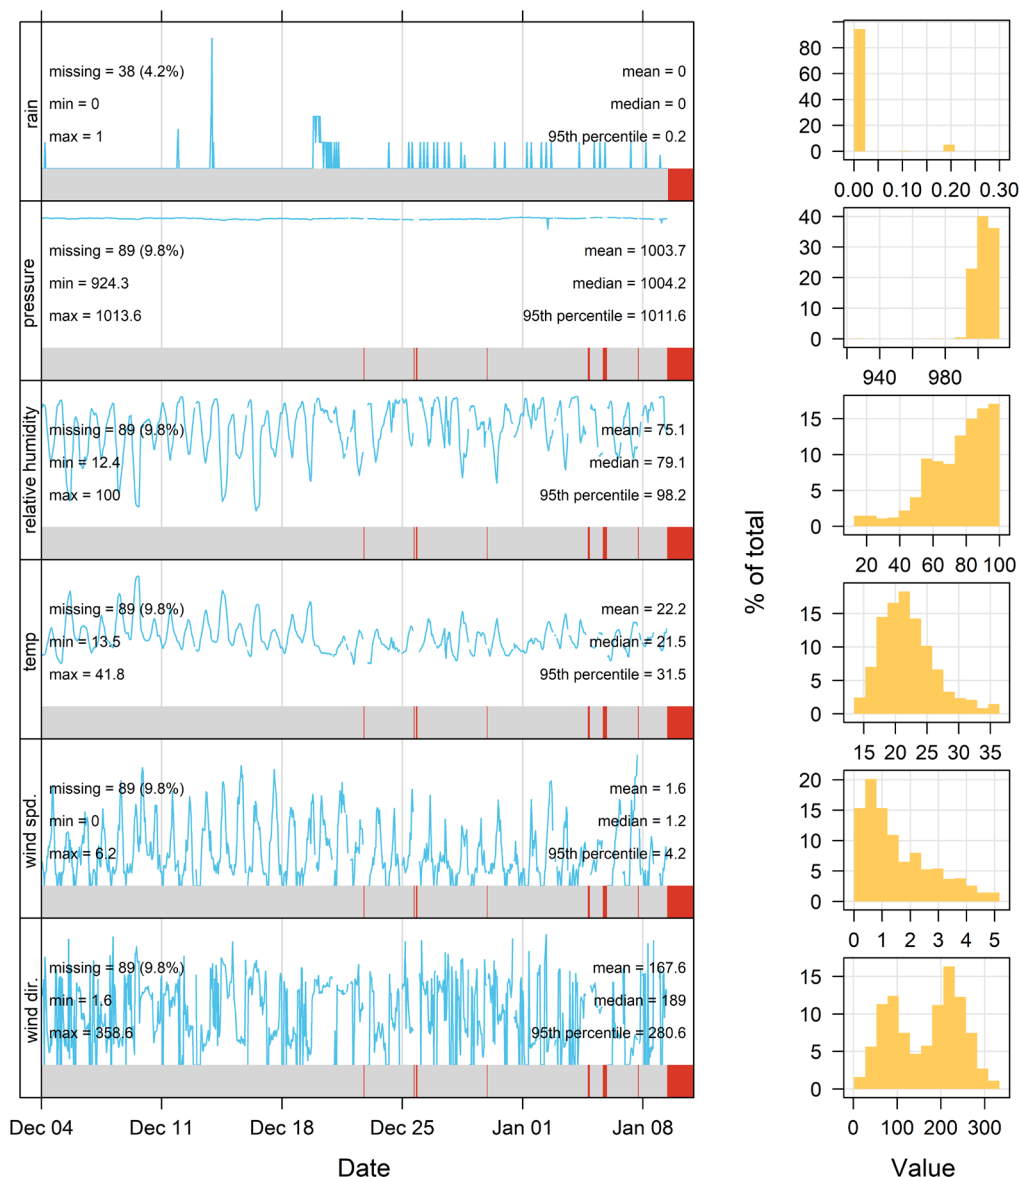
Figure 4.2 Meteorological data summary – Menangle AWS – Period 2

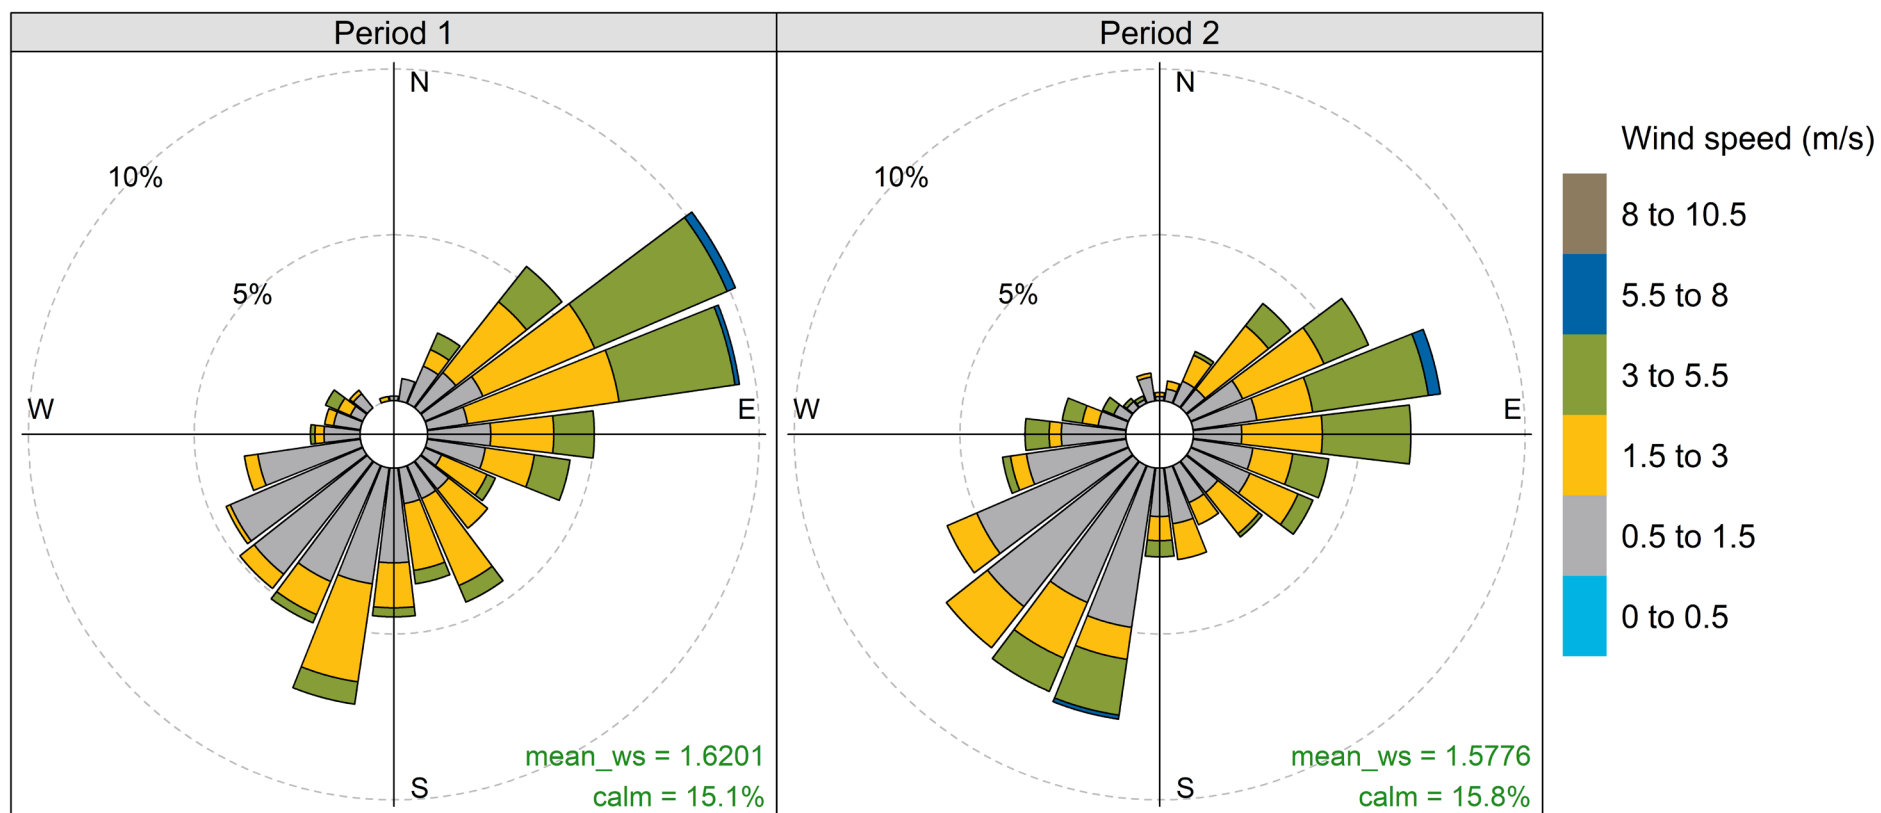
The wind roses for each of the campaign periods at Menangle Quarry are shown in Figure 4.3. Winds across the two periods were influenced by prevailing winds from the north-east, east and south-westerly directions.

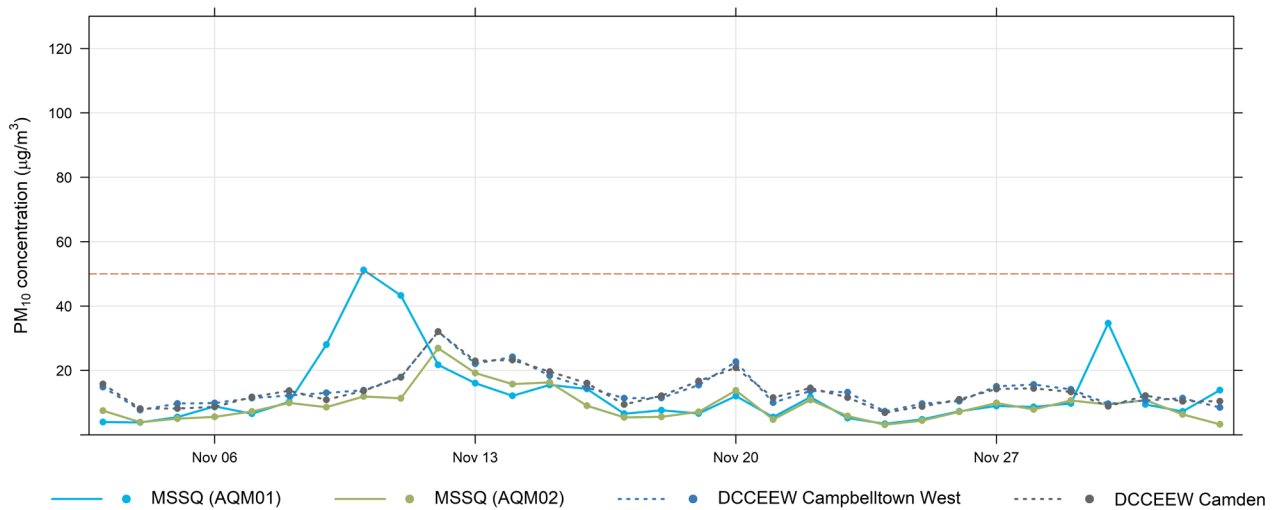
Note: red broken line marks 24-hour average PM₁₀ criterion of 50 µg/m³

Figure 5.3 Daily-varying 24-hour average PM₁₀ concentration – Period 1

The time series of 24-hour PM₁₀ concentrations recorded from the two onsite monitoring locations and the DCCEE Campbelltown and Camden AQMS for the two campaigns are plotted in Figure 5.3 and Figure 5.4 respectively. The concentrations at the four sites were generally similar across the two campaign periods, with exception of two notable concentration spikes recorded at AQM01 during Period 1 which were not recorded at the other three locations.

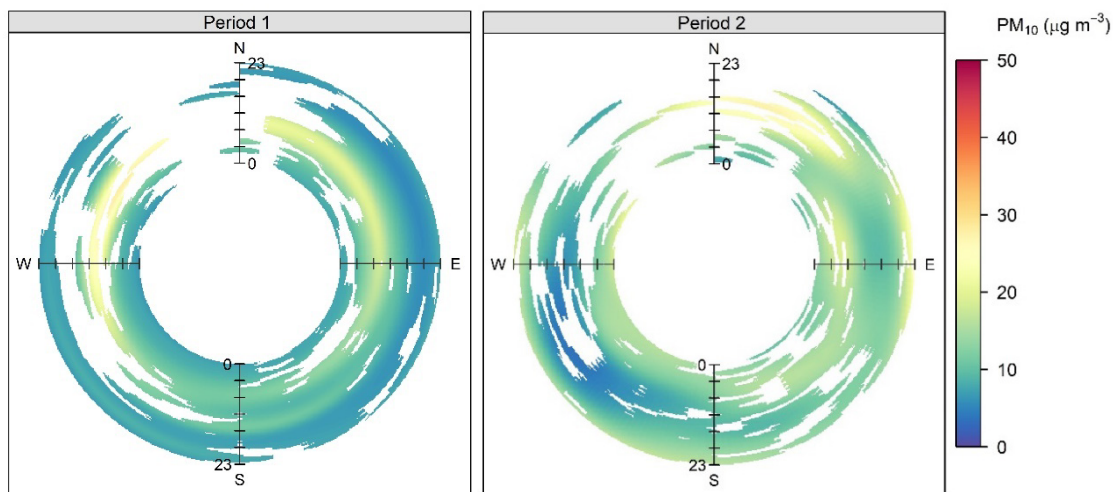
- The polar annulus plot for AQM01 (Figure 5.9) during Period 1 show that the highest concentrations occur during the morning (between 8:00 am to 12:00 pm) and are likely to be associated with operations at the site
- The polar annulus plots for AQM01 and AQM02 (Figure 5.9 and Figure 5.10, respectively) during Period 2 show that the highest concentrations occur between 12:00 pm to 4:00 pm. The polar annulus plots for DCCEW Campbelltown West and Camden AQMS (Figure 5.11 and Figure 5.12, respectively) during Period 2 show that the highest concentrations occur between 12:00 pm to 4:00 pm, would indicate regional scale influences across the four sites.

Figure 5.9 Polar annulus plots for PM₁₀ at AQM01 – Period 1 and 2

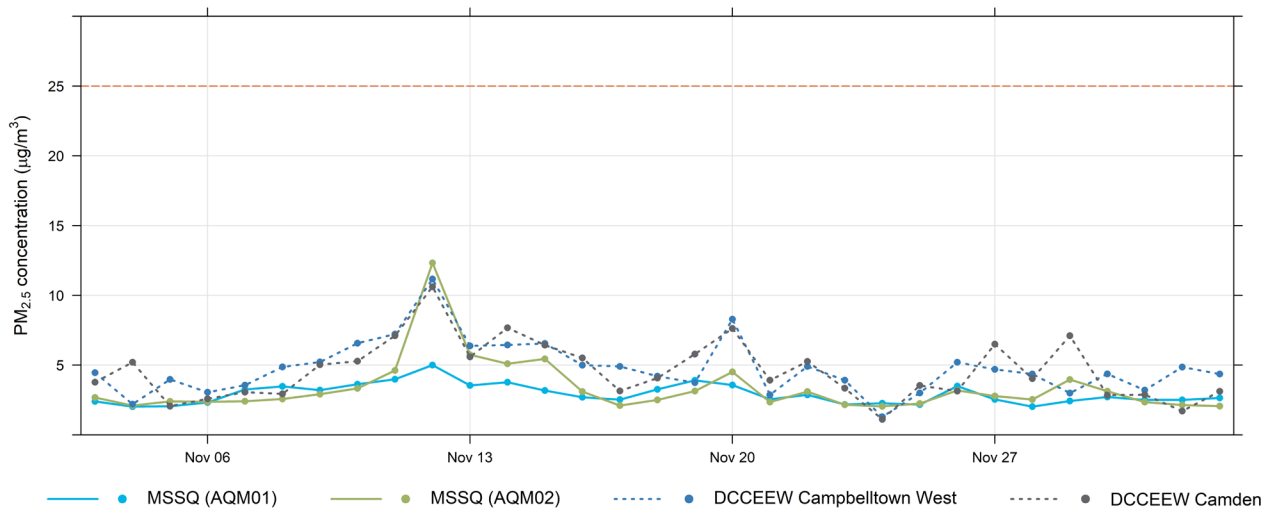
Note: red broken line marks 24-hour average PM_{2.5} criterion of 25 µg/m³

Figure 5.13 Daily mean PM_{2.5} concentration – Period 1

The time series of 24-hour PM_{2.5} concentrations recorded from the onsite monitors and DCCEEW Campbelltown and Camden AQMS for the two campaigns are plotted in Figure 5.13 and Figure 5.14 respectively. For both periods PM_{2.5} concentrations across the four locations generally followed a similar trend.

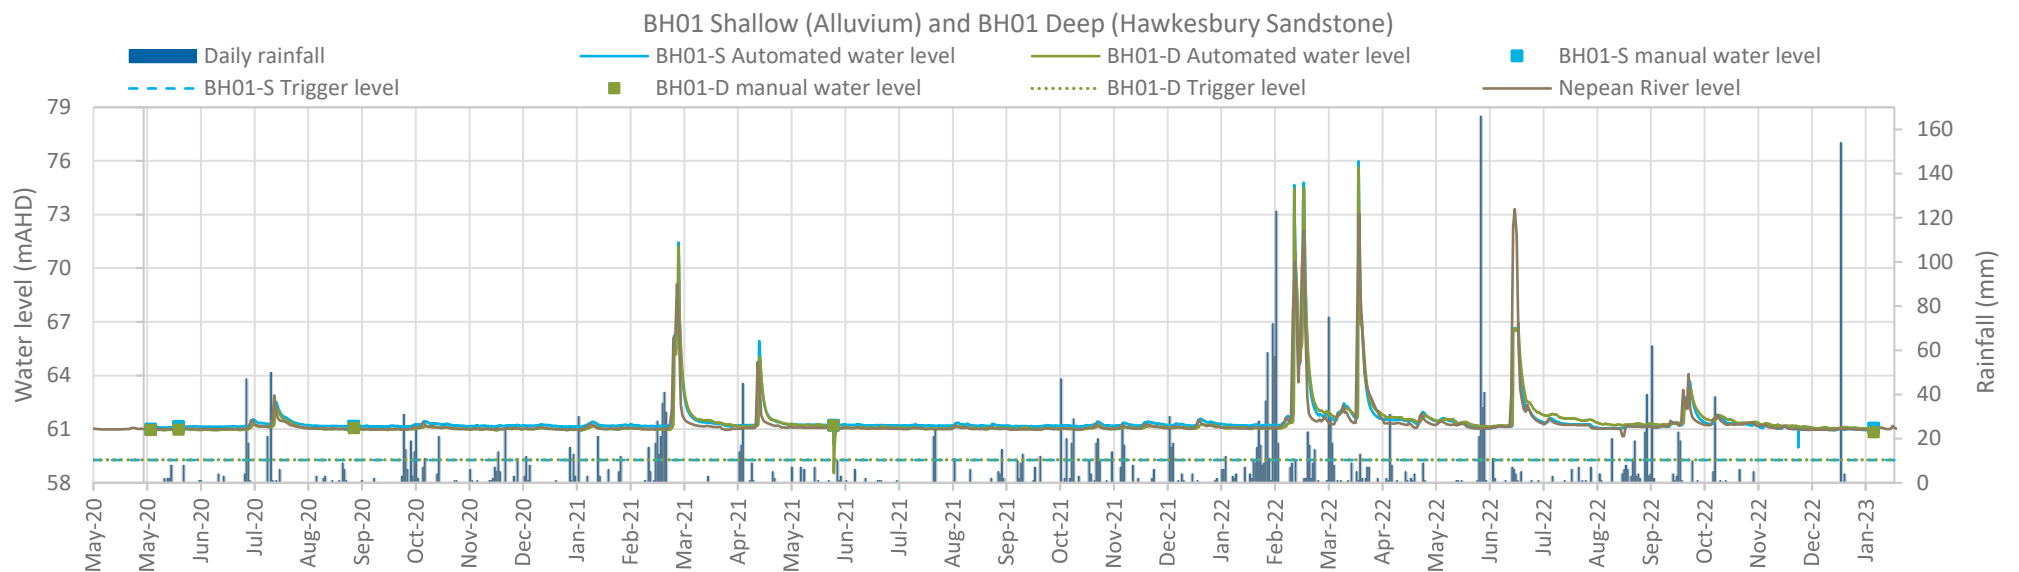
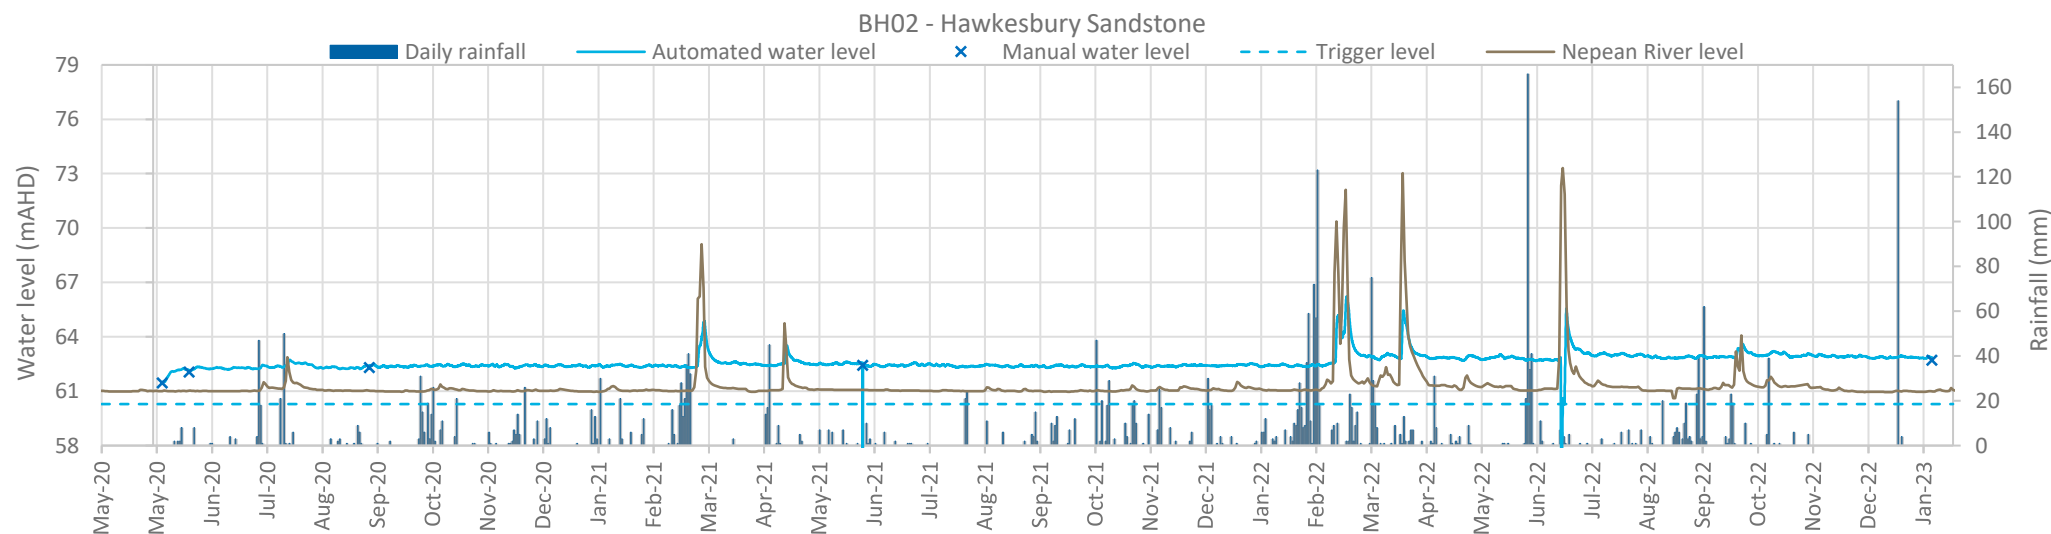
No groundwater level exceedances were observed over the monitoring period (18 June 2021 – 20 January 2023).

Figure 2.2 Time series data – BH01_S, BH01_D and BH02

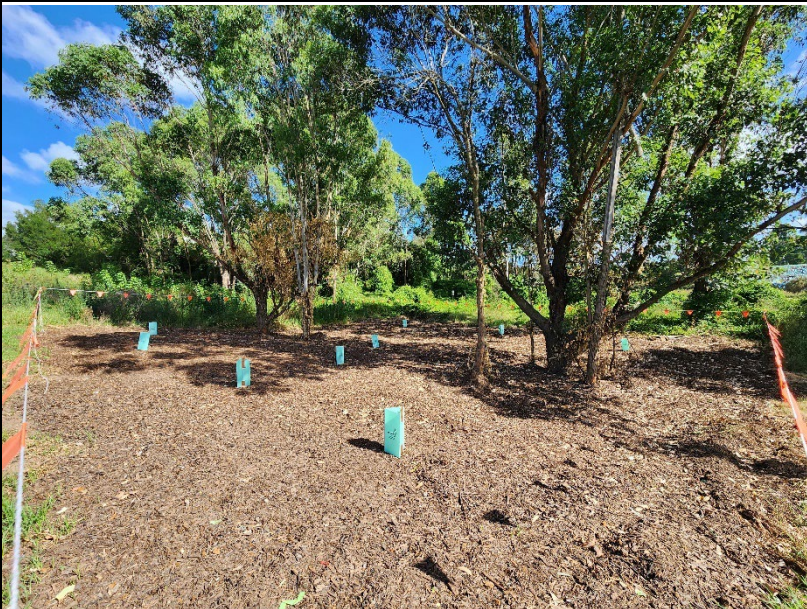
Photo-point monitoring		
Last year(N/A)		This year (05/03/24)
Site	6.1	<p>N/A: 2023 is the first year of monitoring.</p>

Photo-point no.	1	
Comments about how to take the photo consistently each time, improvements, problems, etc.:		
<p>Photo was taken with camera resting upon top of star picket with plot label corflute sign attached. Photo taken at 45 degree angle across site from star picket.</p>

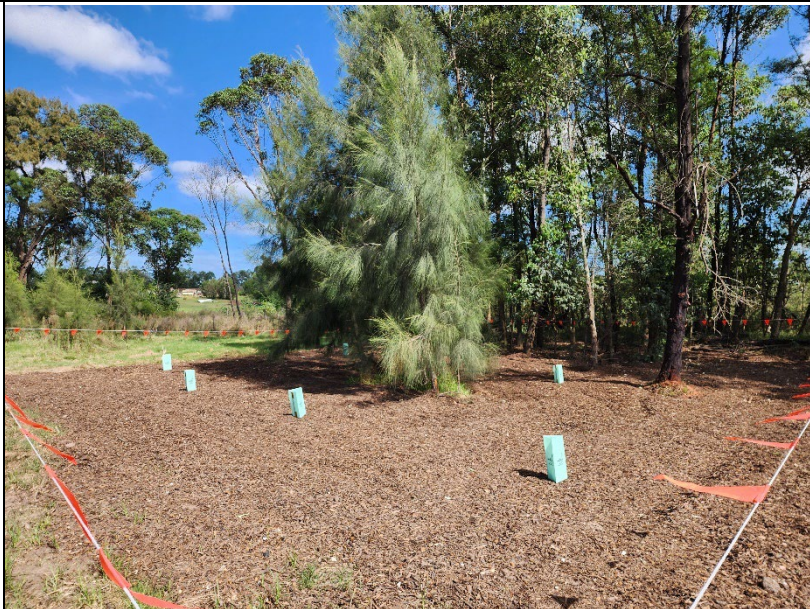
Photo-point monitoring		
Last year(N/A)		This year (05/03/24)
Site	6.2

Photo-point no.	1	
Comments about how to take the photo consistently each time, improvements, problems, etc.:		
Photo was taken with camera resting upon top of star picket with plot label corflute sign attached. Photo taken at 45 degree angle across site from star picket.

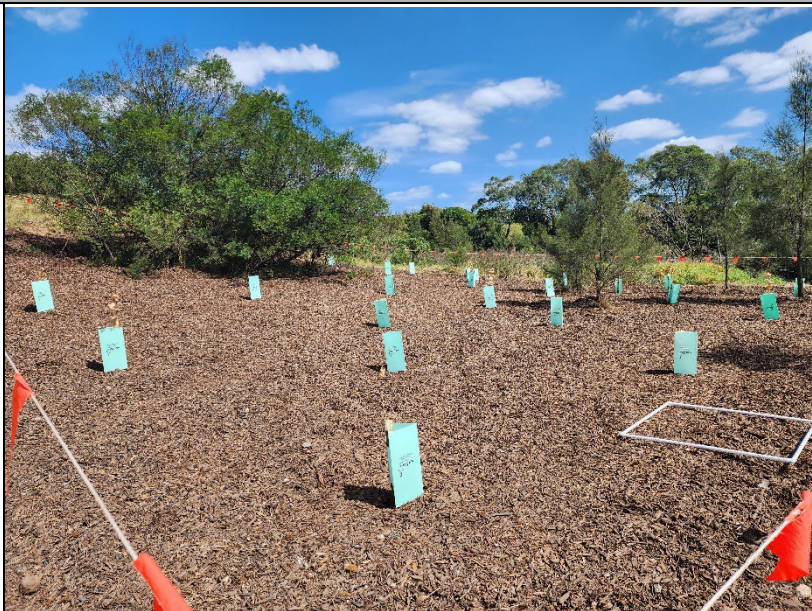
Photo-point monitoring		
Last year(N/A)		This year (05/03/24)
Site	7.1

Photo-point no.	1	
Comments about how to take the photo consistently each time, improvements, problems, etc.:		
Photo was taken with camera resting upon top of star picket resting upon top of star picket with plot label corflute sign attached. Photo taken at 45 degree angle across site from star picket.

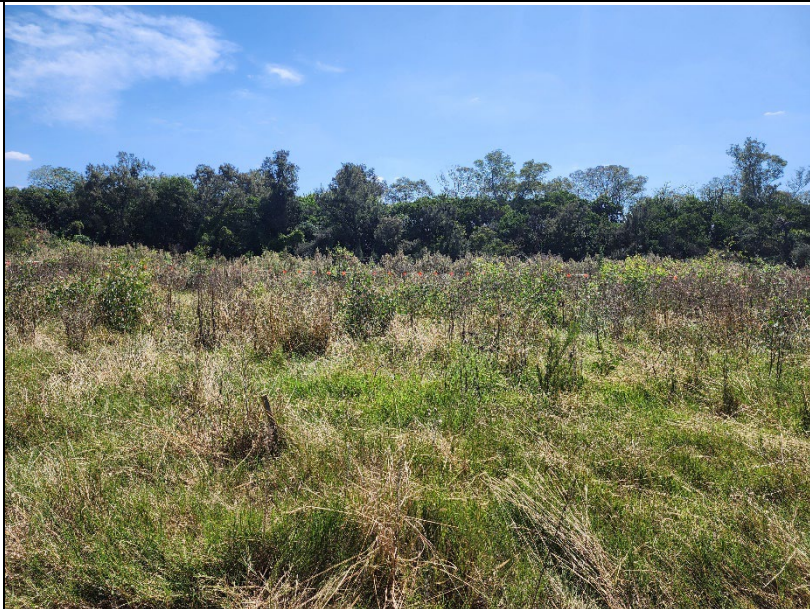
Photo-point monitoring		
Last year(N/A)		This year (05/03/24)
Site	7.3

Photo-point no.	1	
Comments about how to take the photo consistently each time, improvements, problems, etc.:		
Photo was taken with camera resting upon top of star picket with plot label corflute sign attached. Photo taken perpendicular to star picket across site.

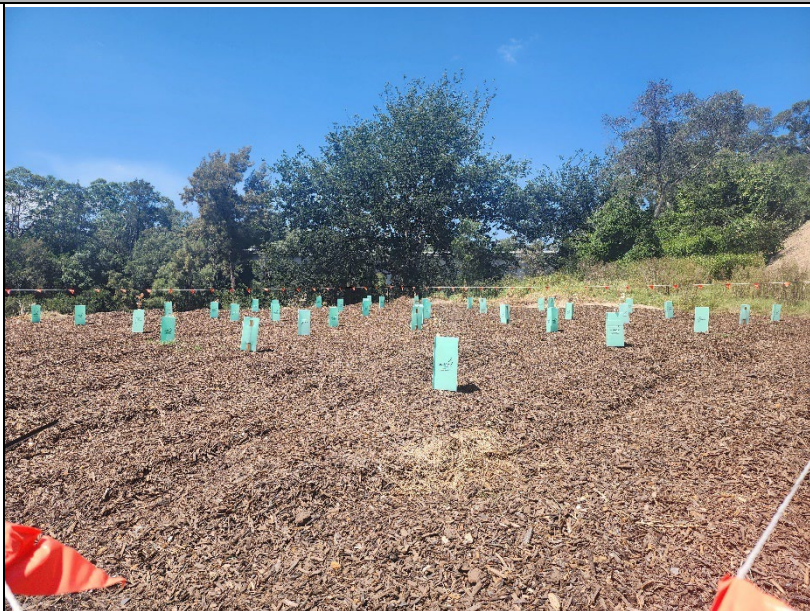
Photo-point monitoring		
Last year(N/A)		This year (05/03/24)
Site	7.5

Photo-point no.	1	
Comments about how to take the photo consistently each time, improvements, problems, etc.:		
Photo was taken with camera resting upon top of star picket with plot label corflute sign attached. Photo taken at 45 degree angle across site from star picket.

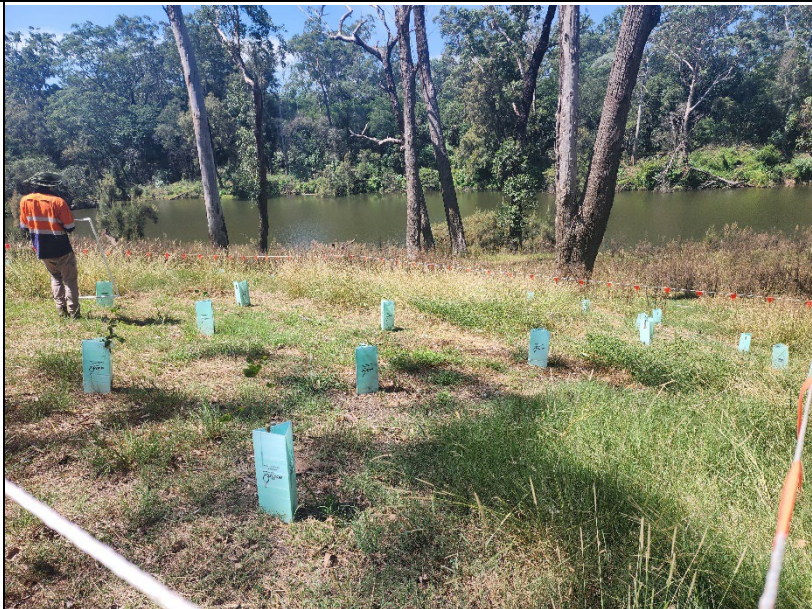
Photo-point monitoring		
Last year(N/A)		This year (05/03/24)
Site	8R1.1

Photo-point no.	1	
Comments about how to take the photo consistently each time, improvements, problems, etc.:		
Photo was taken with camera resting upon top of star picket with plot label corflute sign attached. Photo taken at 45 degree angle across site from star picket.

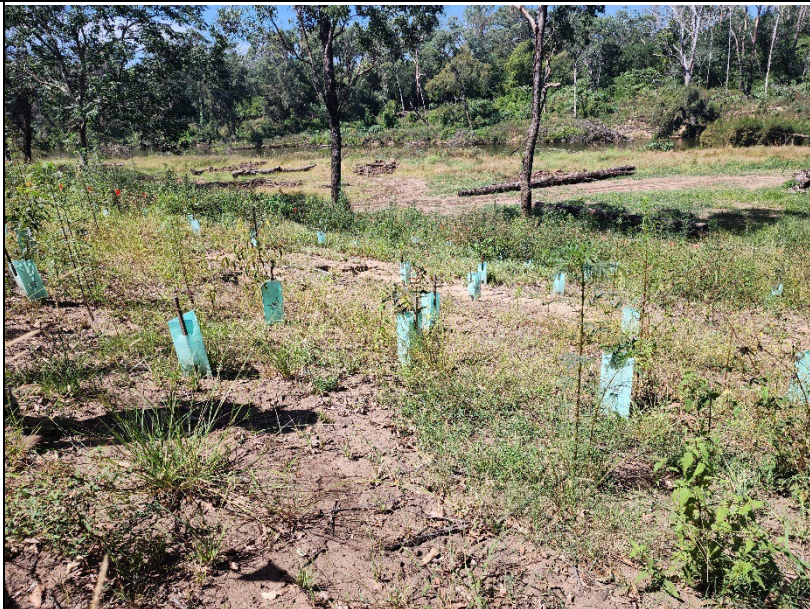
Photo-point monitoring		
Last year(N/A)		This year (05/03/24)
Site	8R1.2

Photo-point no.	1	
Comments about how to take the photo consistently each time, improvements, problems, etc.:		
Photo was taken with camera resting upon top of star picket with plot label corflute sign attached. Photo taken at 45 degree angle across site from star picket.

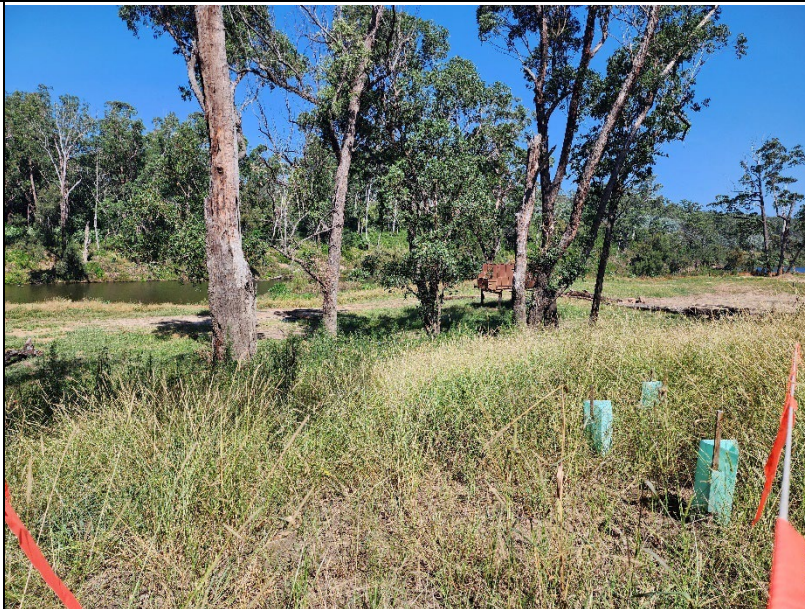
Photo-point monitoring		
Last year(N/A)		This year (05/03/24)
Site	8R1.3

Photo-point no.	1	
Comments about how to take the photo consistently each time, improvements, problems, etc.:		
Photo was taken with camera resting upon top of star picket with plot label corflute sign attached. Photo taken at 45 degree angle across site from star picket.

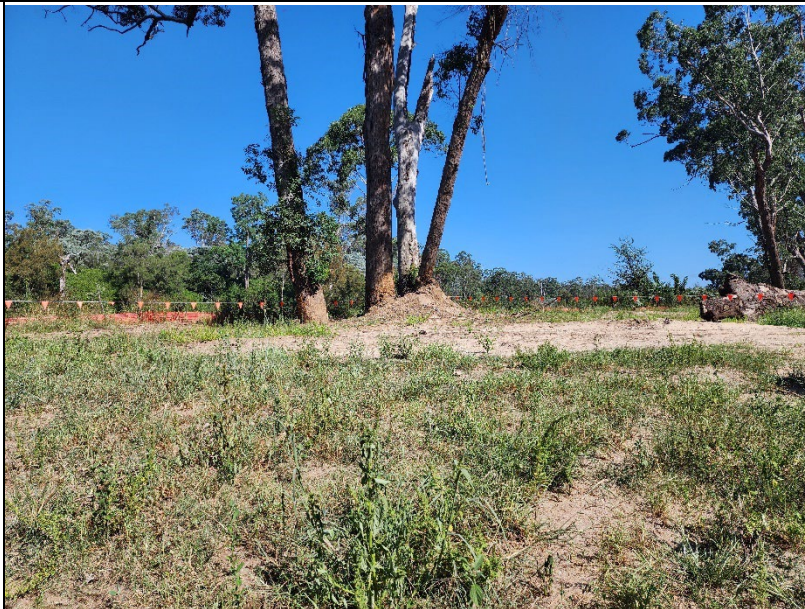
Photo-point monitoring		
Last year(N/A)		This year (05/03/24)
Site	8A.1

Photo-point no.	1	
Comments about how to take the photo consistently each time, improvements, problems, etc.:		
Photo was taken with camera resting upon top of star picket with plot label corflute sign attached. Photo taken at 45 degree angle across site from star picket.

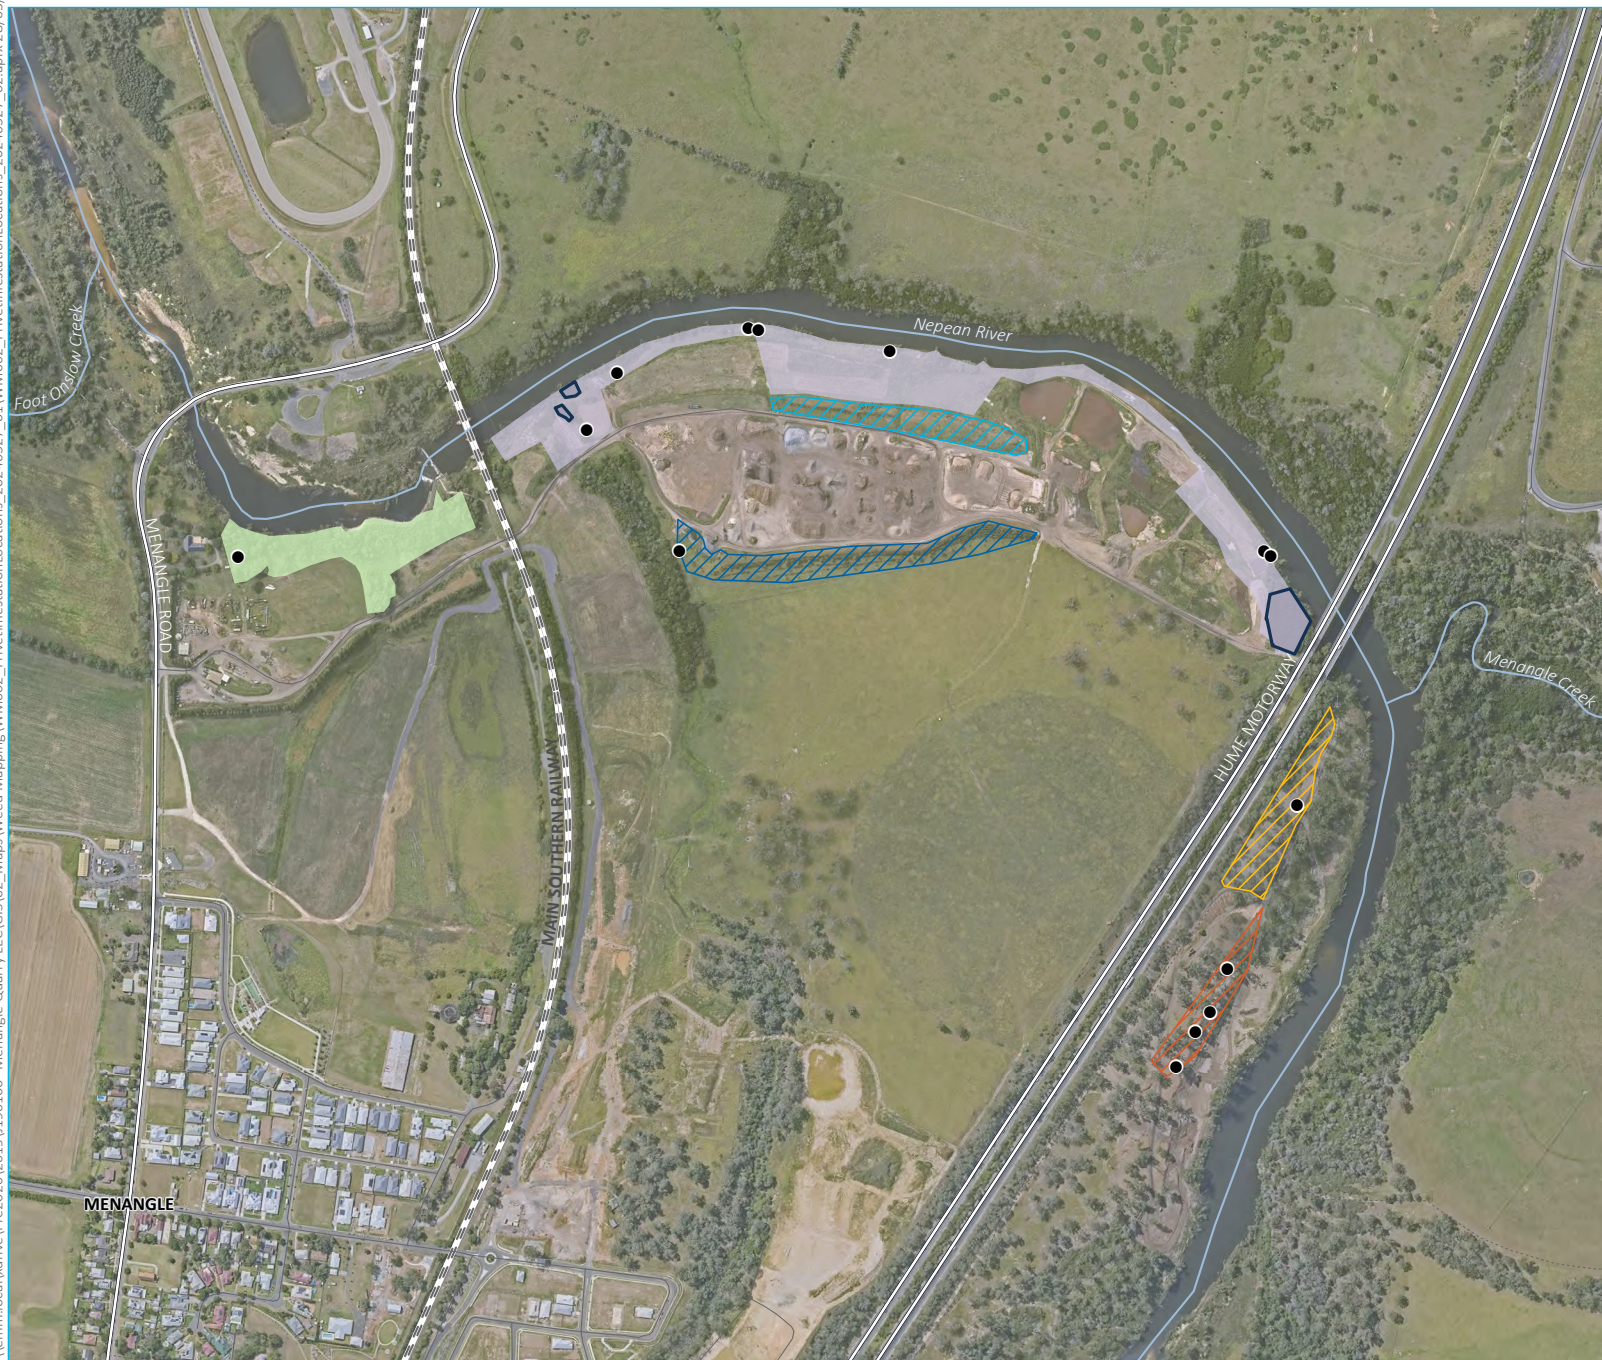
Weed Mapping
Figure 3.1

Date	Area (eg Substage 8A)	Surveyed area (ha)	Lantana			Privet			Species	Novel weed species		
			Cover (ha)	Cover (%)	Locations Patches >25 m ² : see map below Patches 1–25 m ² : see map below or provide coordinates	Cover (ha)	Cover (%)	Locations Patches >25 m ² : see map below Patches 1–25 m ² : see map below or provide coordinates		Cover (ha)	Cover (%)	Locations Patches >25 m ² : see map below Patches 1–25 m ² : see map below or provide coordinates
6/3/2024	Stage 6	2.3	0	0	N/A	0	0	N/A	N/A	N/A	N/A	N/A
6/3/2024	Stage 7	7.41	0.36	80	See maps below	0.41	80	See maps below	N/A	N/A	N/A	N/A
6/3/2024	Stage 8	6.51	0.21	40	See maps below	0.1	100	See maps below	N/A	N/A	N/A	N/A

Lantana infestation location

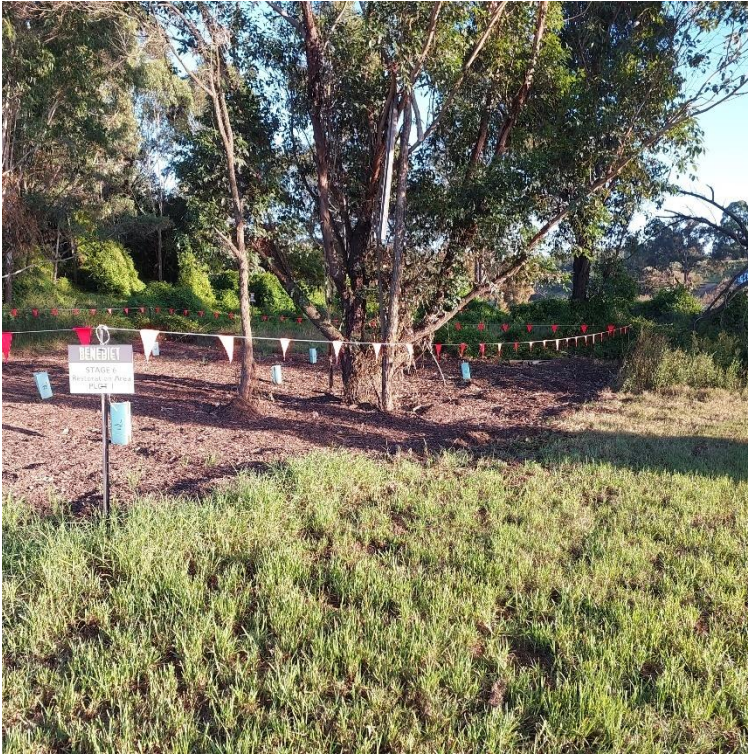
It was observed that Plot 6.1 had had significant treatment works conducted including removal of debris, placement of a mulch layer, and plantation with tree guards erected around plantings (Photograph 5.1). The plantings were unsuccessful, due to unknown reasons. Mulch has also been applied, with the understood intent of suppressing weed growth, however the mulch is also likely to suppress native plant growth.

Photograph 5.1 Stage 6 Plot 6.1

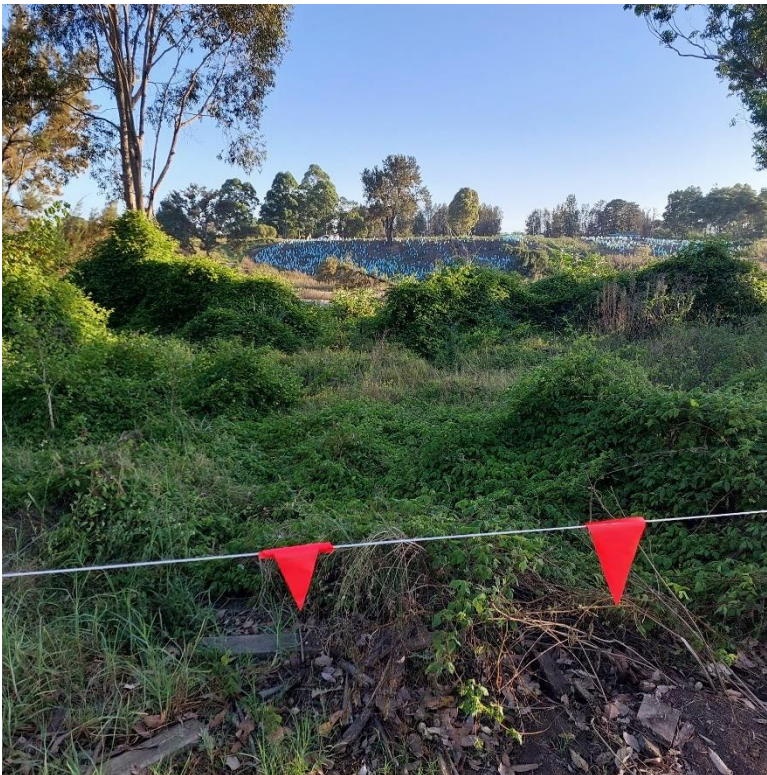
Heavy weed growth was observed in the remainder of the Stage 6 rehabilitation area (outside of the plots) where additional rehabilitation works, including weed control and seeding/planting, will be required (Photograph 5.2) to enhance the historical rehabilitation in this area.

Photograph 5.2 Stage 6 Plot 6.1 – looking past plot to Nepean Riverbank (red triangles and rope is the plot tape)

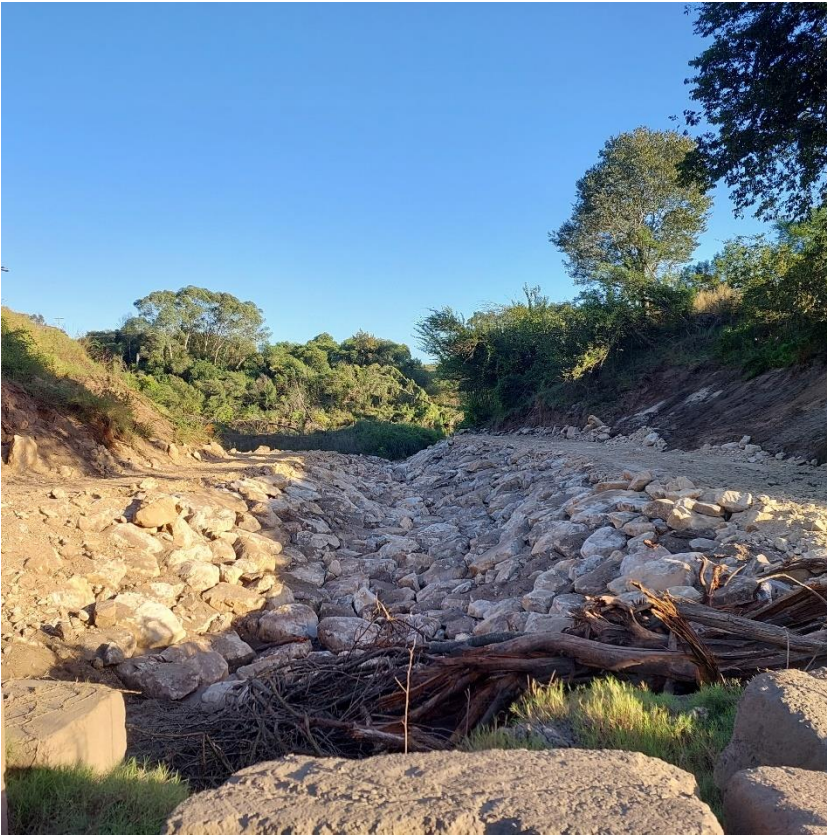
The creek-line to the west (approximately 30 m to the west of Plot 7.1 established by Menangle Sand and Soil, to the north of the site access road) was observed to have been stabilised with large rocks (Photograph 5.3). This is likely to reduce the potential for scour and erosion. Consideration should be given to the long-term revegetation of this area, as establishing native species will further improve landform stability.

Photograph 5.3 Drainage line to the west of Stage 7 Plot 7.1
