Subject: Menangle Quarry - 2023 Annual Review

MENANGLE SAND AND SOIL ANNUAL REVIEW (Condition D9)

Benedict Sands Menangle (LEC 2018/342158)

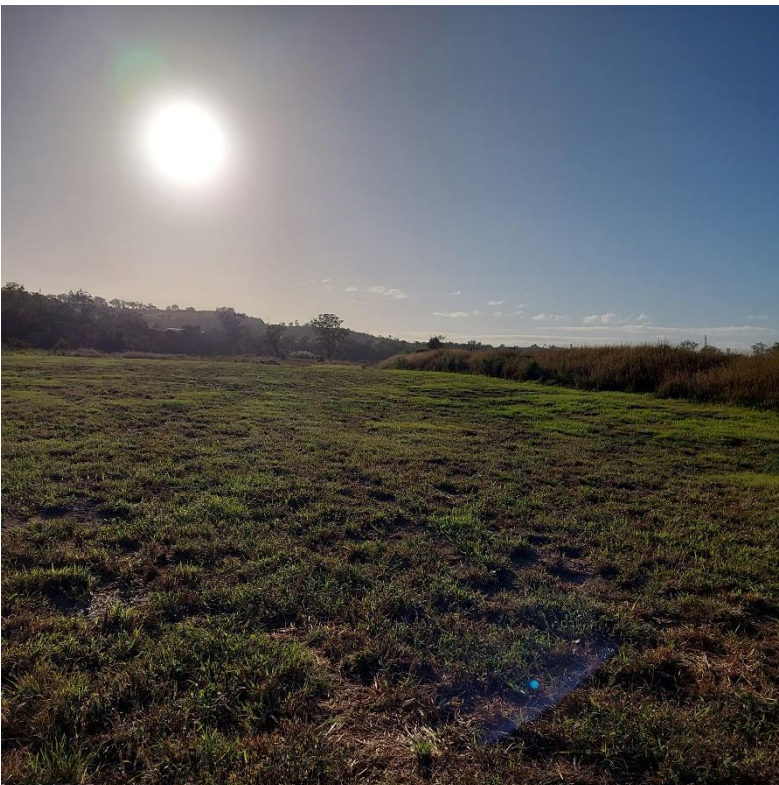
A large dam located between Plots 7.1 and 7.2 has been filled in, and levelled, and is now covered in grass (Photograph 5.4). The landform appeared to be stable, with no signs of erosion visually observed.

Photograph 5.4 Stage 7 area where a dam which has been filled in

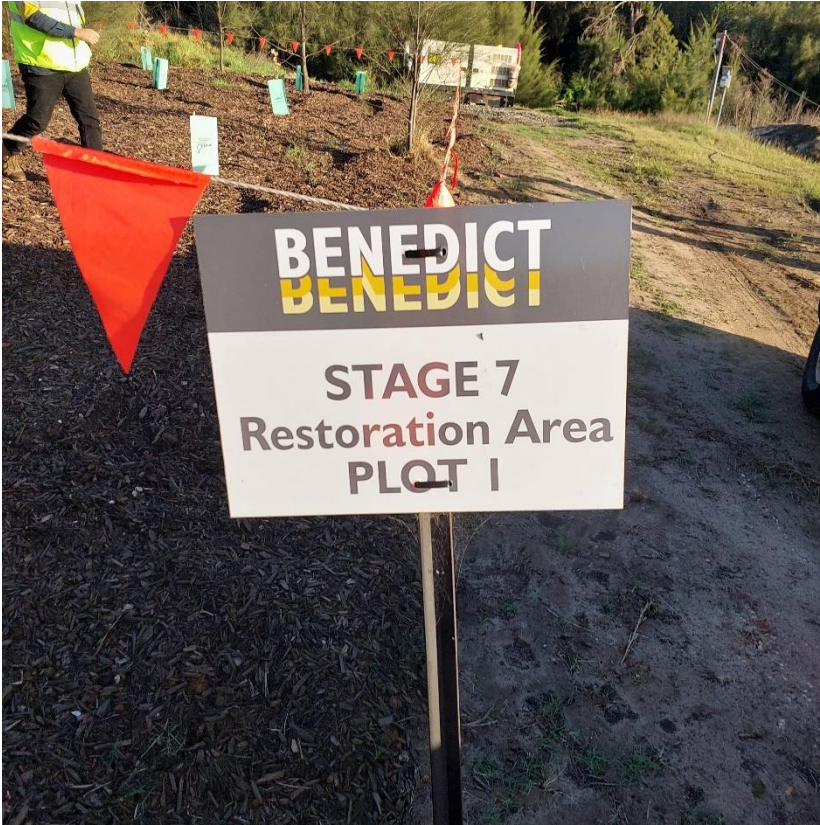
Menangle Sand and Soil have commenced vegetation works with the establishment of five plots (Plots 7.1 to 7.5) within the Stage 7 rehabilitation area (Photograph 5.5 – Photograph 5.9). Revegetation works outside of these plots have not commenced. These plot locations do not coincide with the monitoring plots in Figure 6.2 of the BRMP. Stage 7 has been affected by the same flooding events outlined in Stage 6 (2021 and twice in 2022).

Photograph 5.5 Stage 7 Plot 7.1

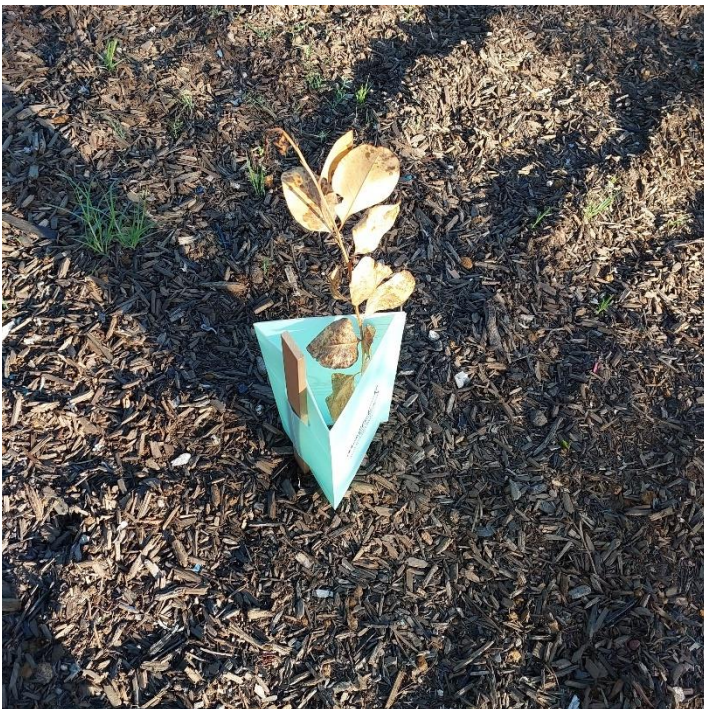
Photograph 5.6 Stage 7 Plot 7.1 – example of unsuccessful planting

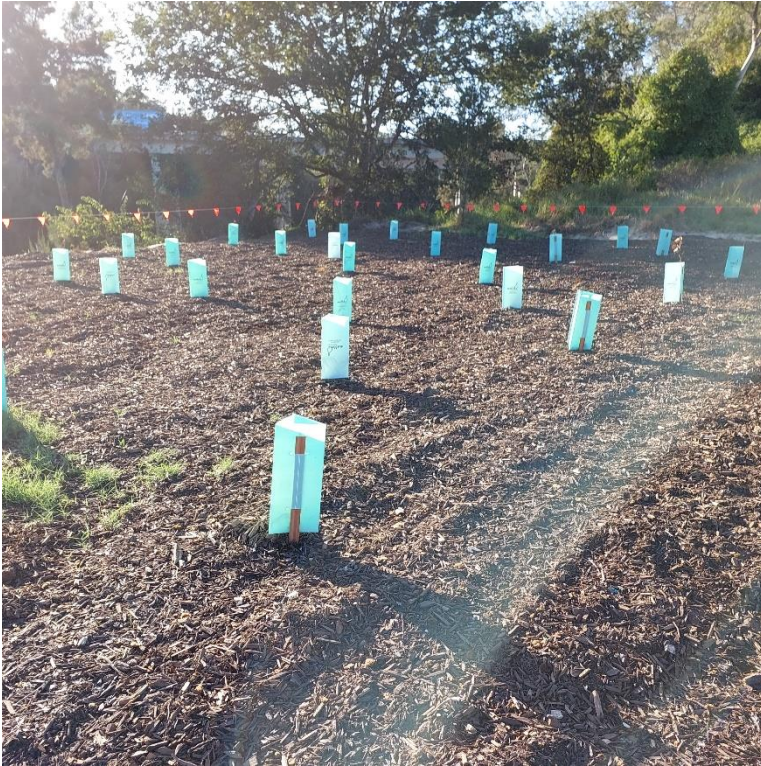
Photograph 5.7 **Stage 7 Plot 7.5 – unsuccessful plantings**

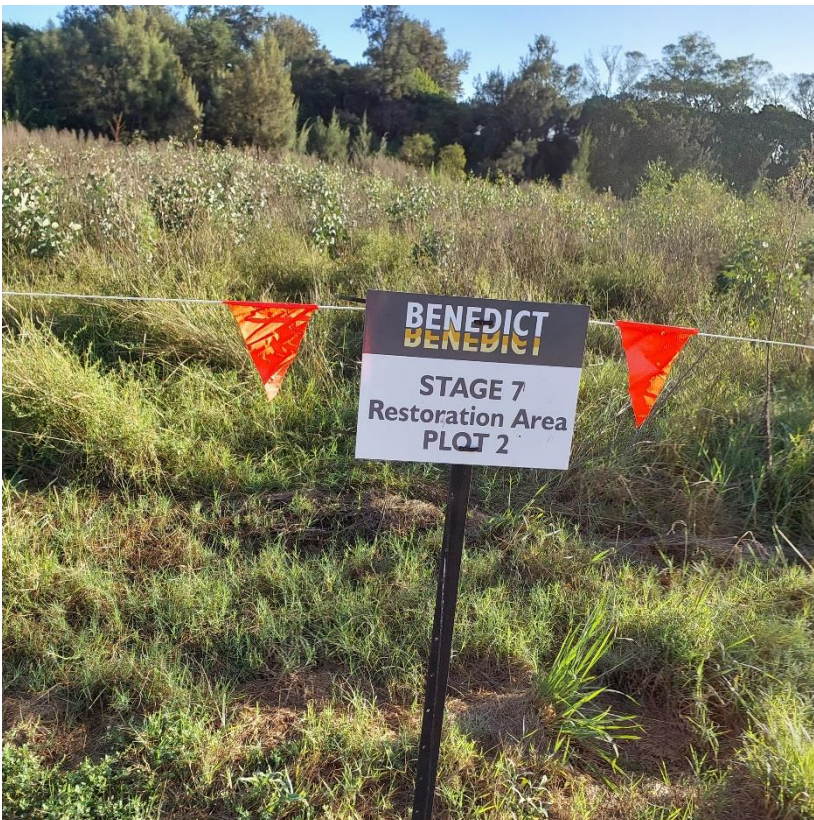
Photograph 5.8 **Stage 7 Plot 7.2**

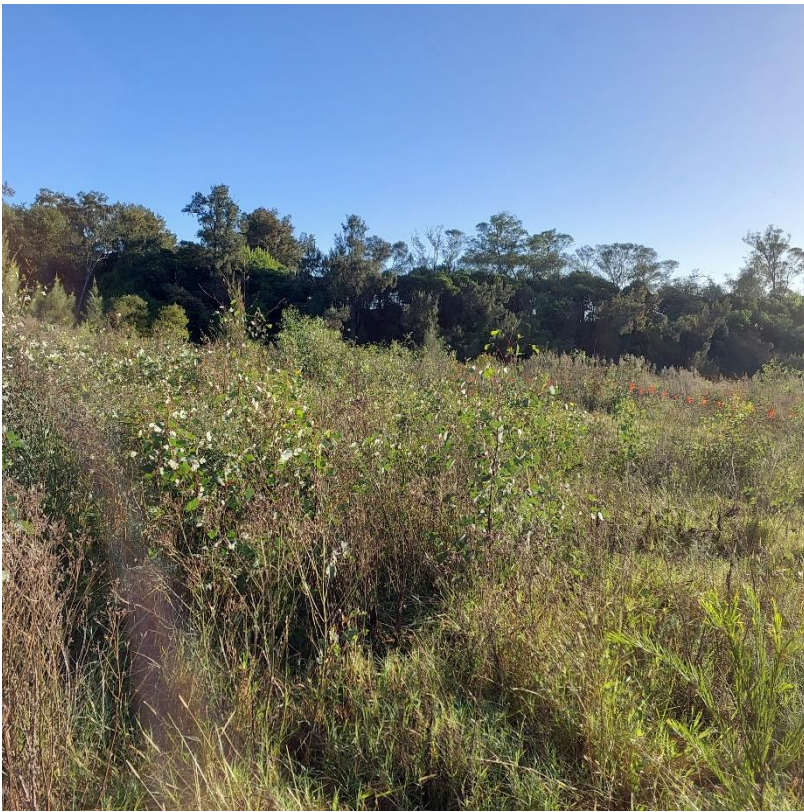
Photograph 5.9 **Stage 7 Plot 7.2 – mix of native and exotic growth, vegetation along the Nepean Riverbank is visible in the rear of the photo.**

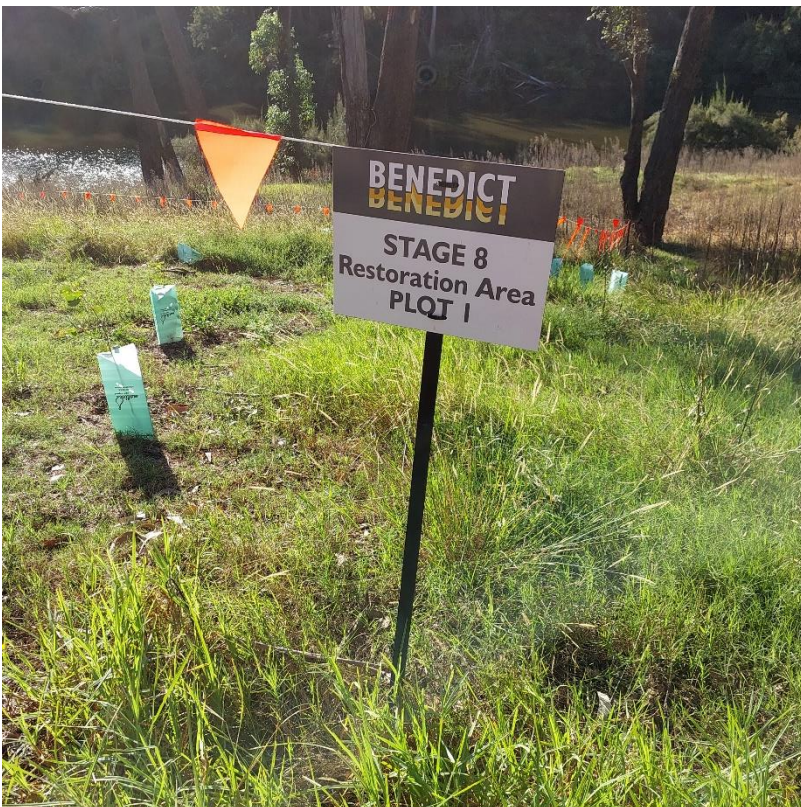
Within Stage 8, vegetation restoration actions to date appear to have concentrated on scalping, and the establishment of the plots. Plantings within tree-guards in Restoration Area 1 Plot R1.1 were observed to have survived (Photograph 5.10). Some plantings were observed outside of the plots, but were limited in extent. Weeds were observed to becoming reestablished within Stage 8 Restoration Area 1 and Substage 8A. Weeds had not yet taken hold in Stage 8B, due to the recent excavation and scalping. Weeds were also observed on the NRBZ and lower riverbank for Stages 8A and 8B. Sowing native seed mix containing species characteristic of River-Flat Eucalypt Forest as per Table 5.1 of the BRMP is strongly recommended to reduce opportunities for further weed establishment when accompanied by manual weed control measures.

Photograph 5.10 **Stage 8 Plot 8.1**

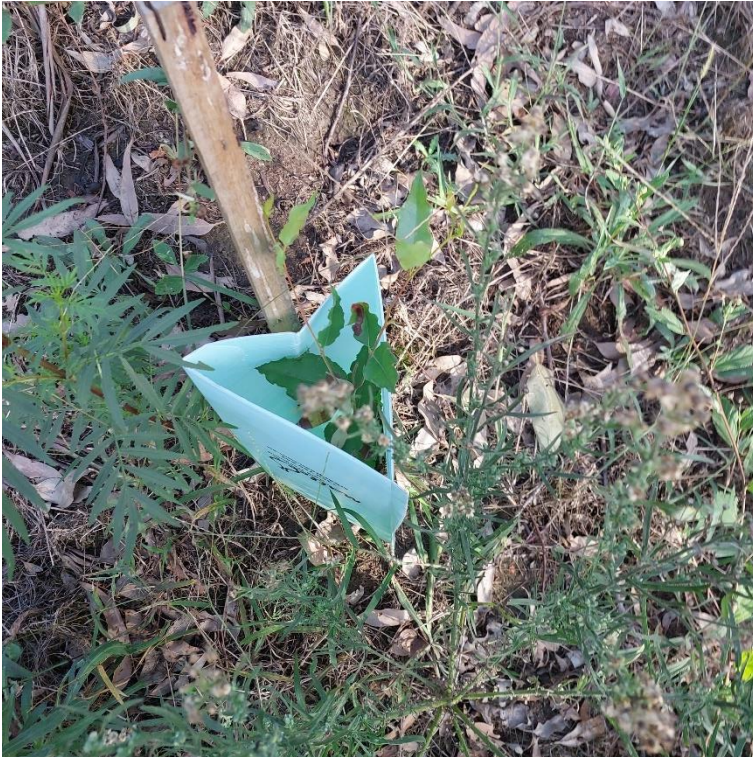
Photograph 5.11 Stage 8 Plot 8.1 – example planting survival

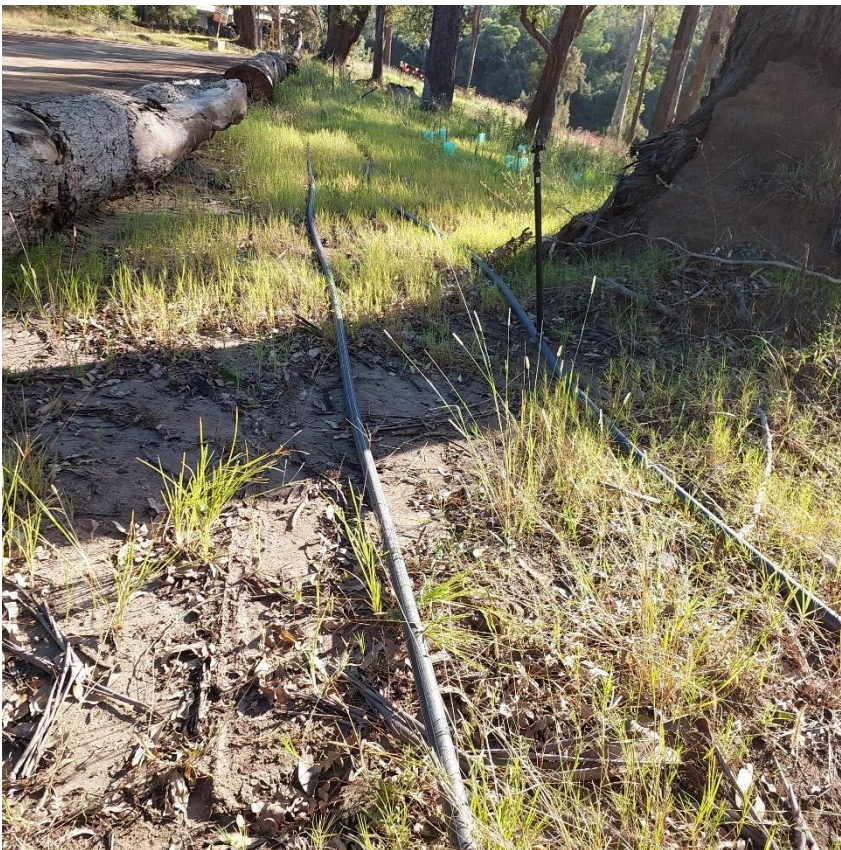
Photograph 5.12 Stage 8 – access track close to Hume Highway, note large logs at the edge of the track to control vehicle movements

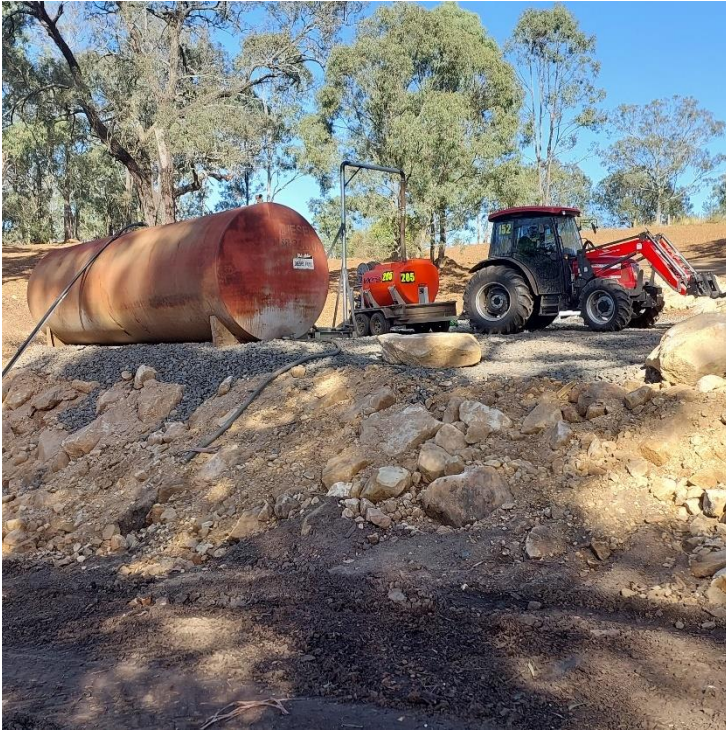
installed, including pipes, sprinklers, and tank (Photograph 5.13). A sediment fence was observed to have been installed on the Nepean Riverbank (Photograph 5.18). Large logs were observed to have been placed in this area.

Photograph 5.13 Stage 8 area irrigation infrastructure

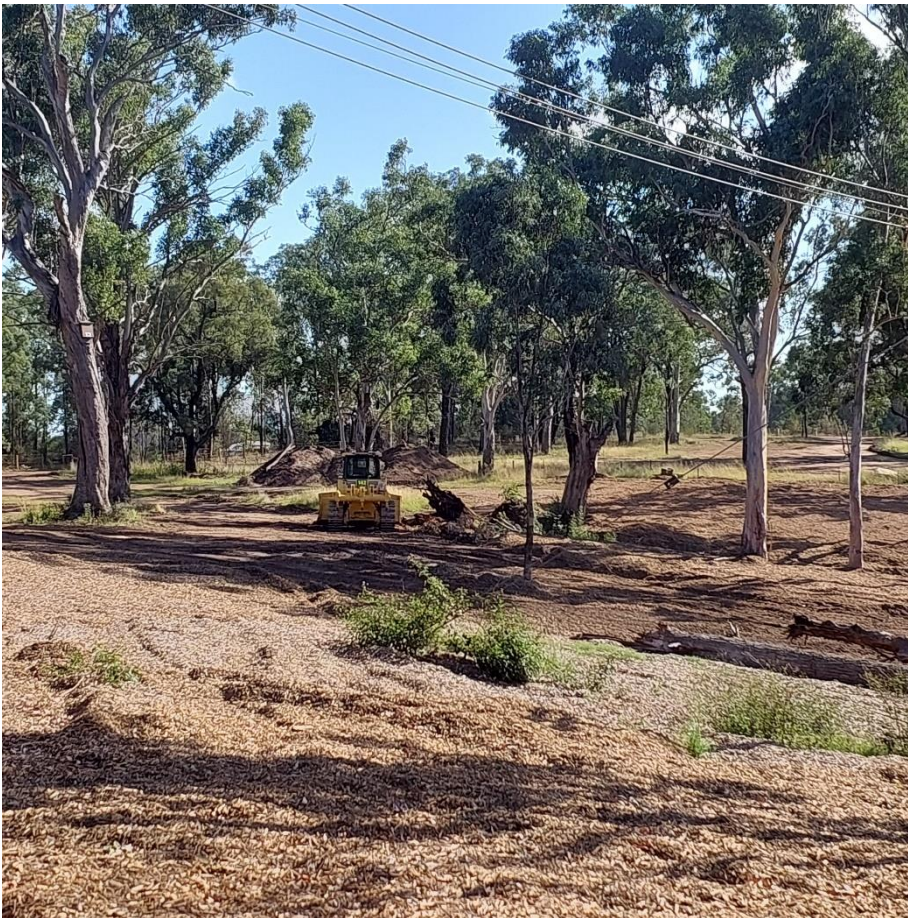
Photograph 5.14 Works to the north of Stage 8 Restoration Area 1

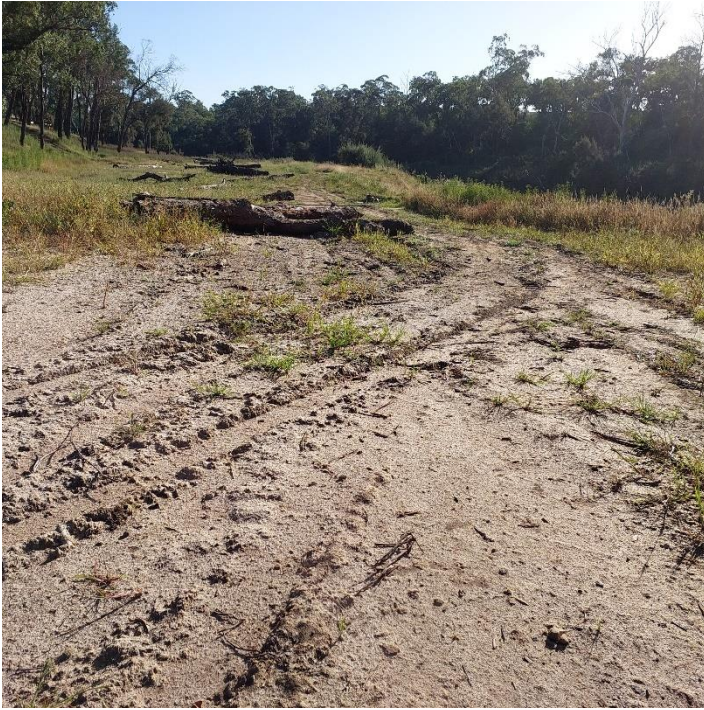
Photograph 5.15 **Stage 8 Restoration Area 1**

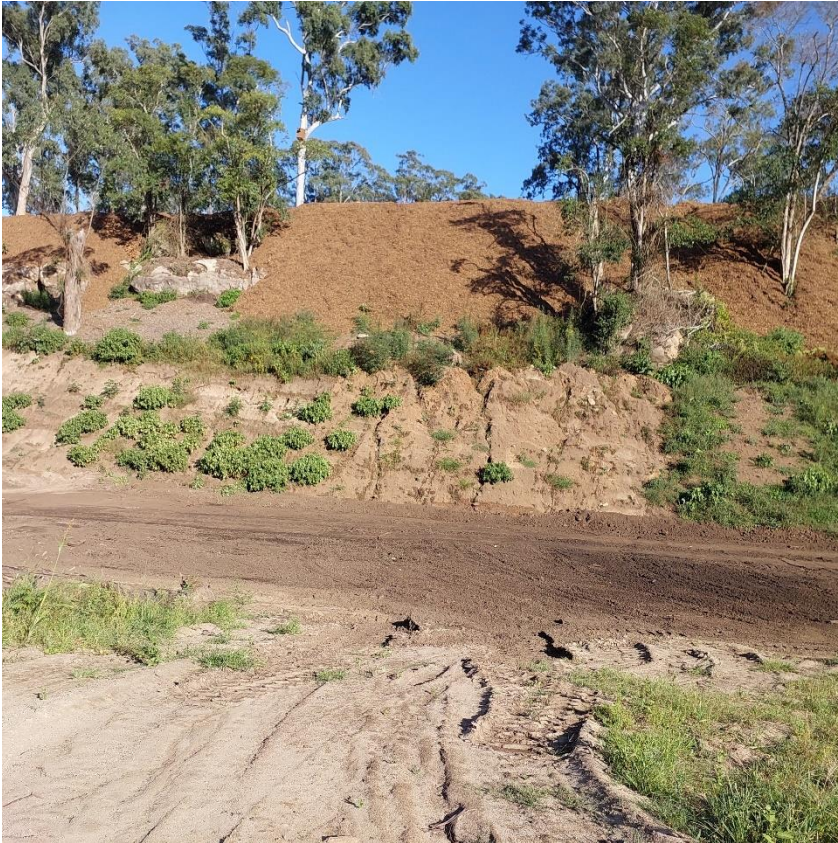
Photograph 5.17 **Stage 8 Restoration Area 1/northern portion of Substage 8A (different locations) – Note mulch at top of slope, and some minor erosion at the base of the slope**

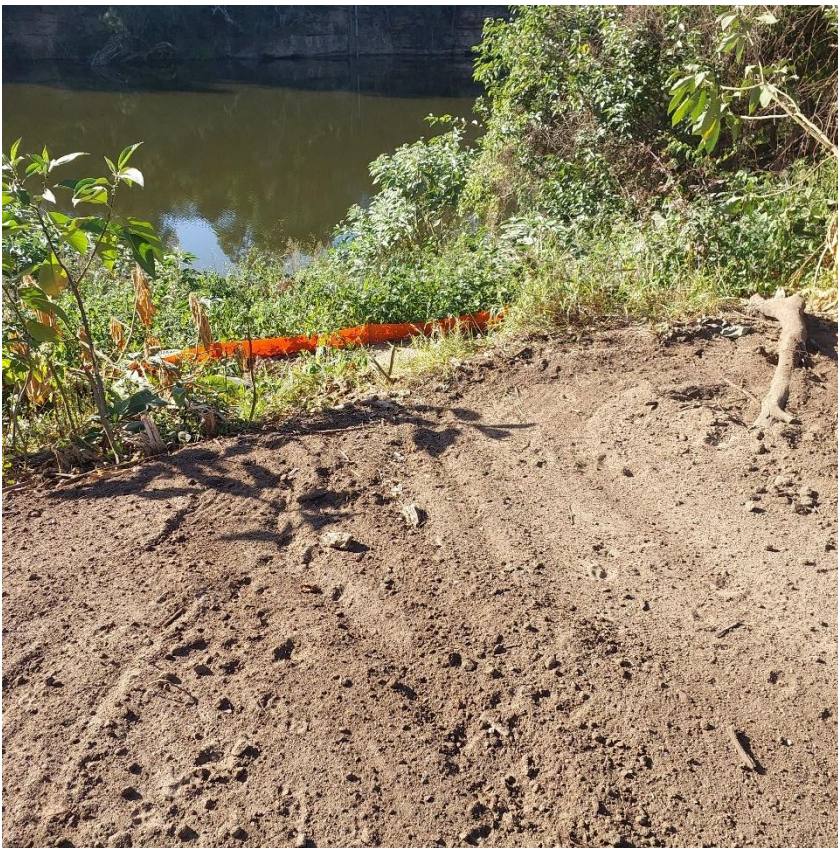
Photograph 5.18 **Stage 8A – sediment fencing**

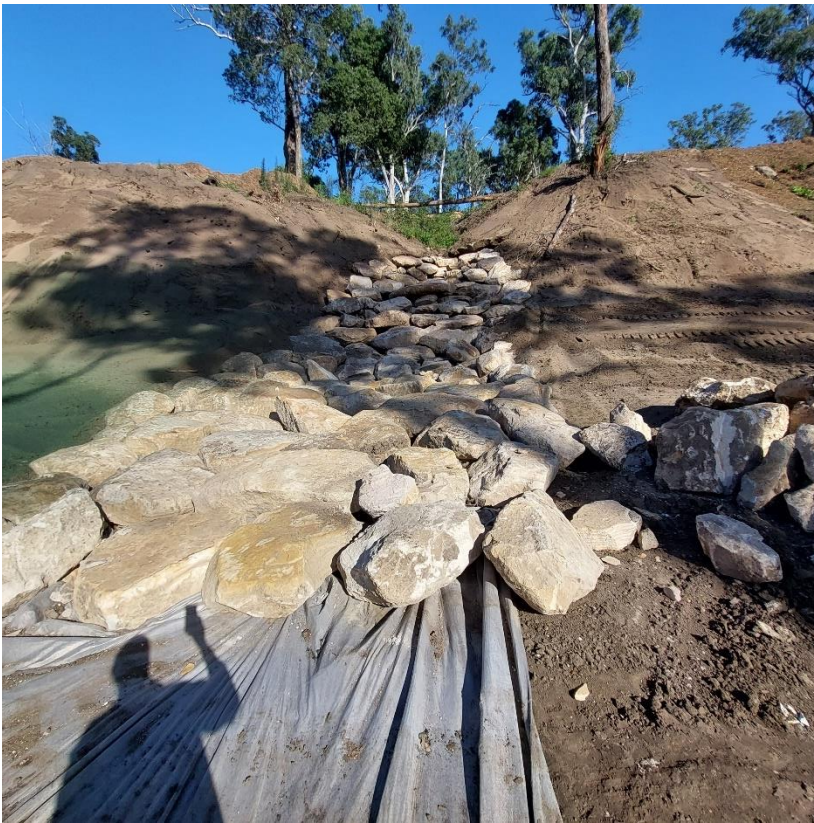
Photograph 5.19 **Stage 8A/8B – Drainage line with scour protection works**

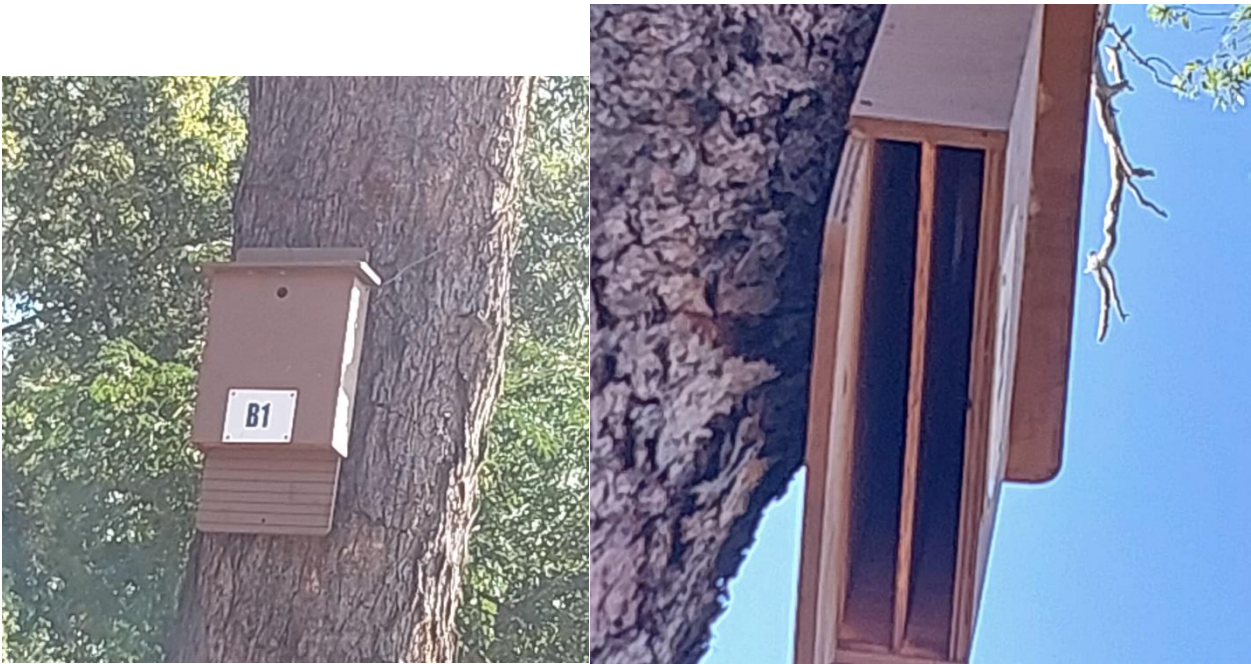
Photograph 5.21 Stage 8 example nestboxes – note plywood used for the bat box B1
