Subject: Menangle Quarry - Annual Review 2024

MENANGLE SAND AND SOIL ANNUAL REVIEW (Condition D9)

Benedict Sands Menangle (LEC 2018/342158)

01 January 2024 - 31 December 2024

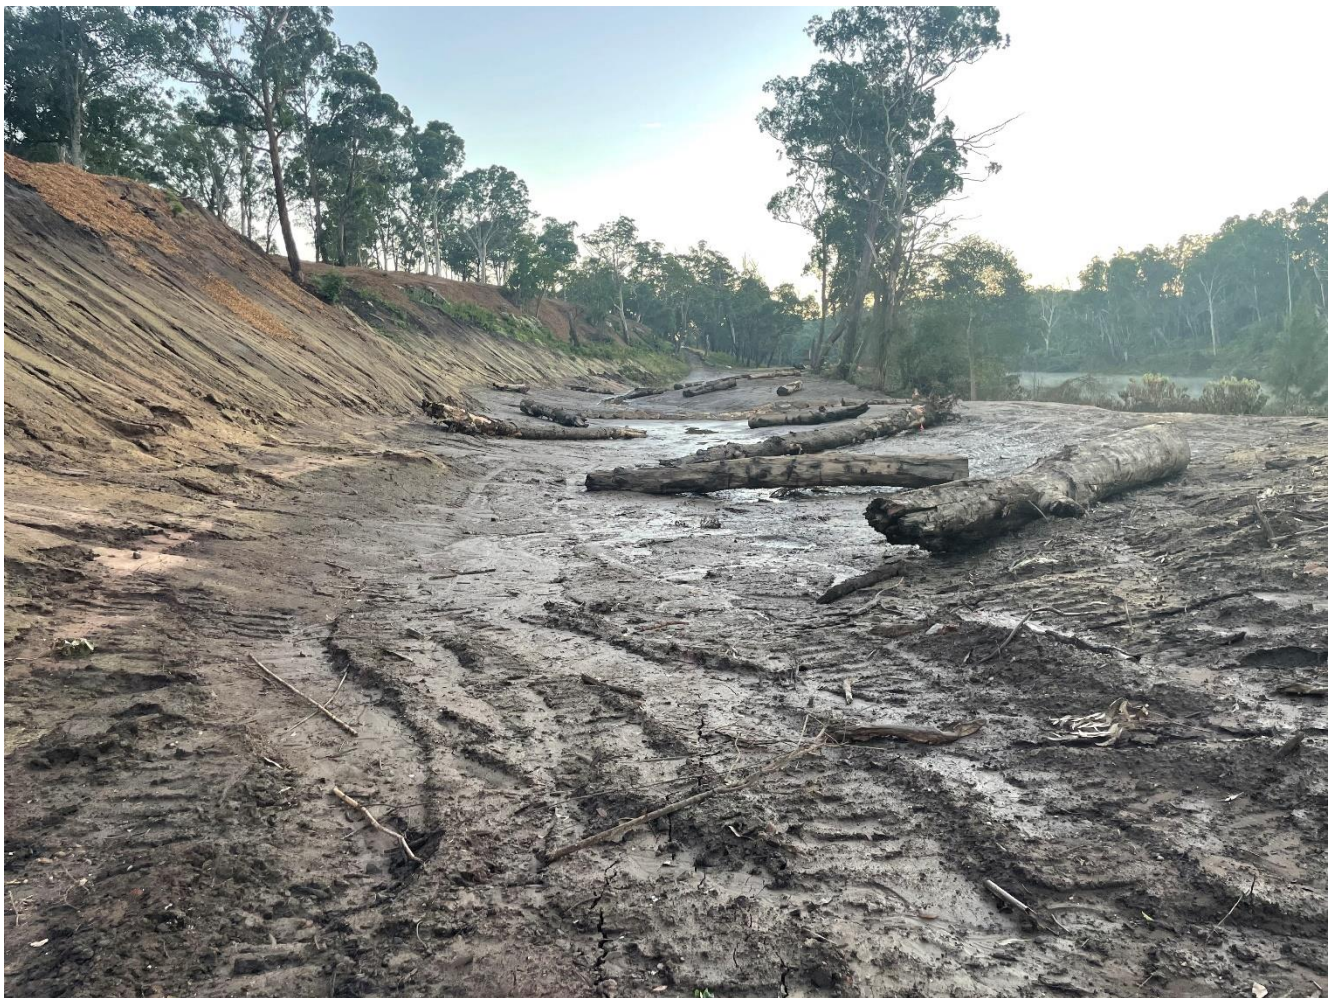
Flood Event – April 6 2024

The responsibilities contained in Table 5.2 Flood scour and risk remedial response TARP, of the Flood Management Plan were followed as below:

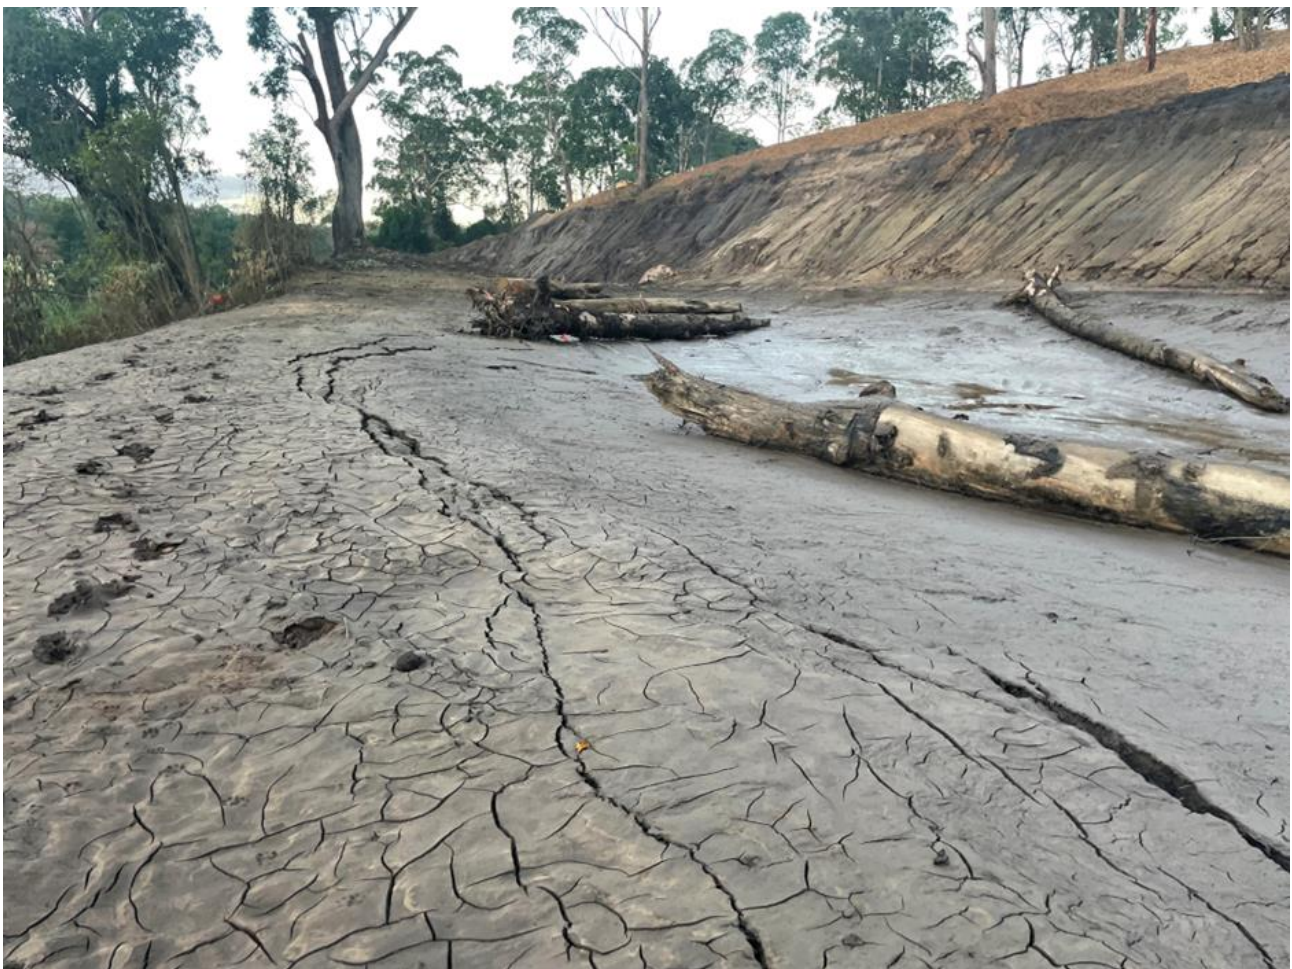
Post flood

Incident Report created – see Attachment G

Clean up debris

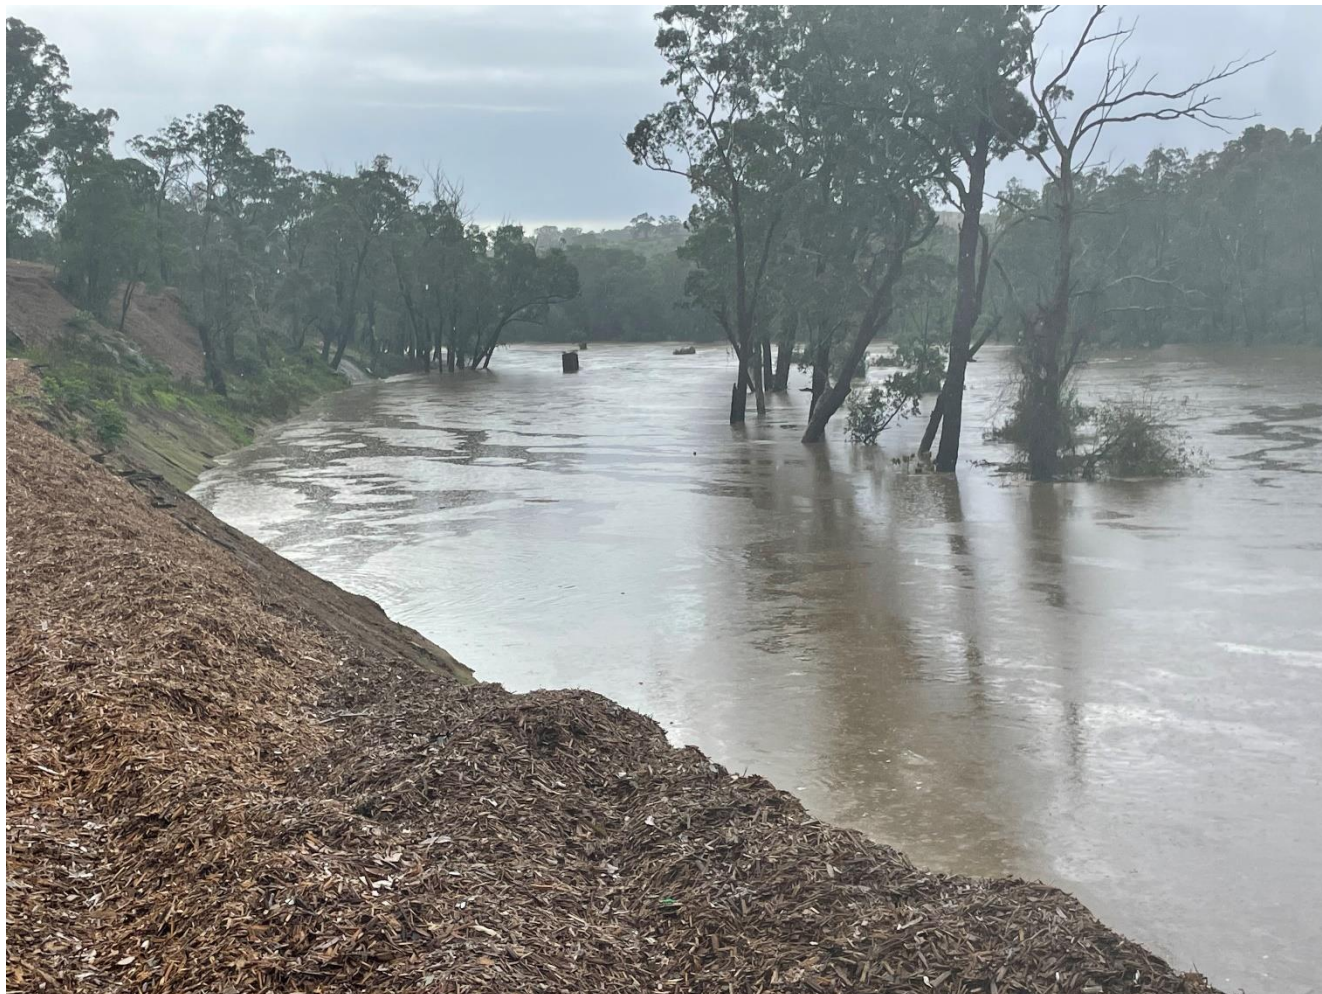
Flood Event - June 6 2024

The responsibilities contained in Table 5.2 Flood scour and risk remedial response TARP, of the Flood Management Plan were followed as below bearing in mind that the recovery from the April flood had not been completed:

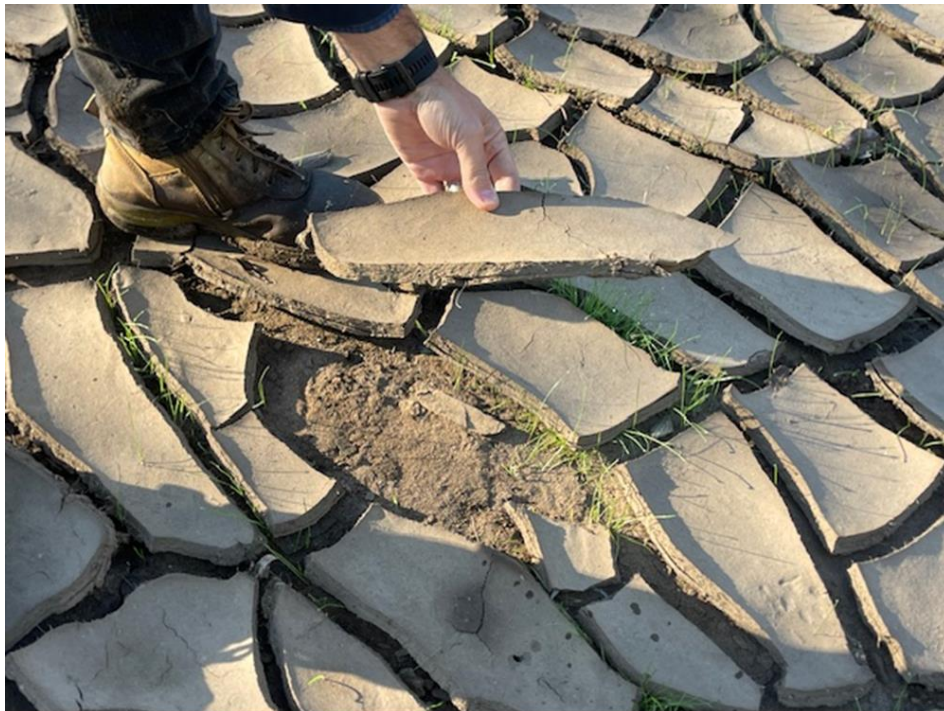
Sediment deposits

Rehabilitation planting strategy was reviewed as the ability to rehabilitate the landform was proving unsustainable.

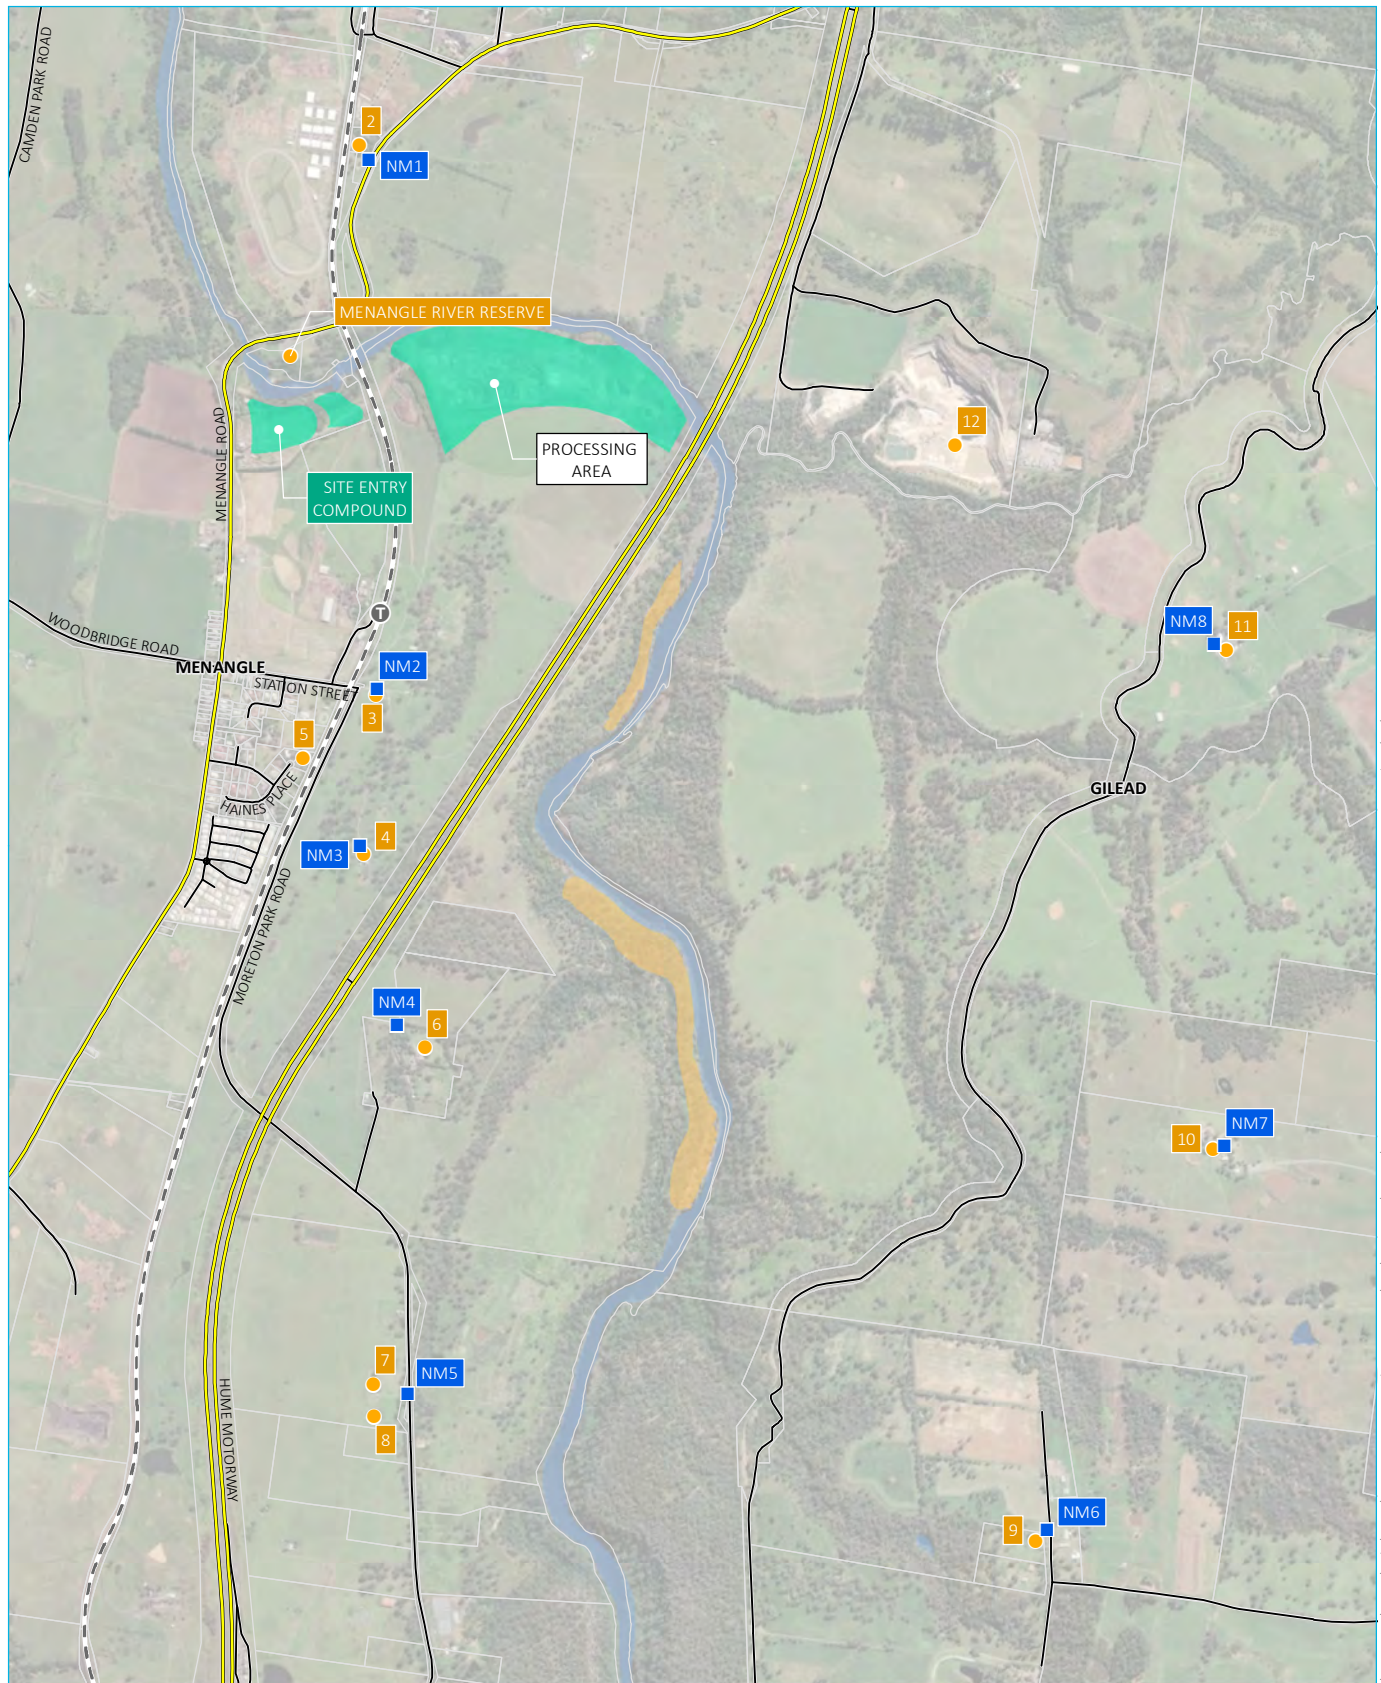
Figure 3.1 shows the site boundary, the nearest sensitive receivers and the attended noise monitoring locations.

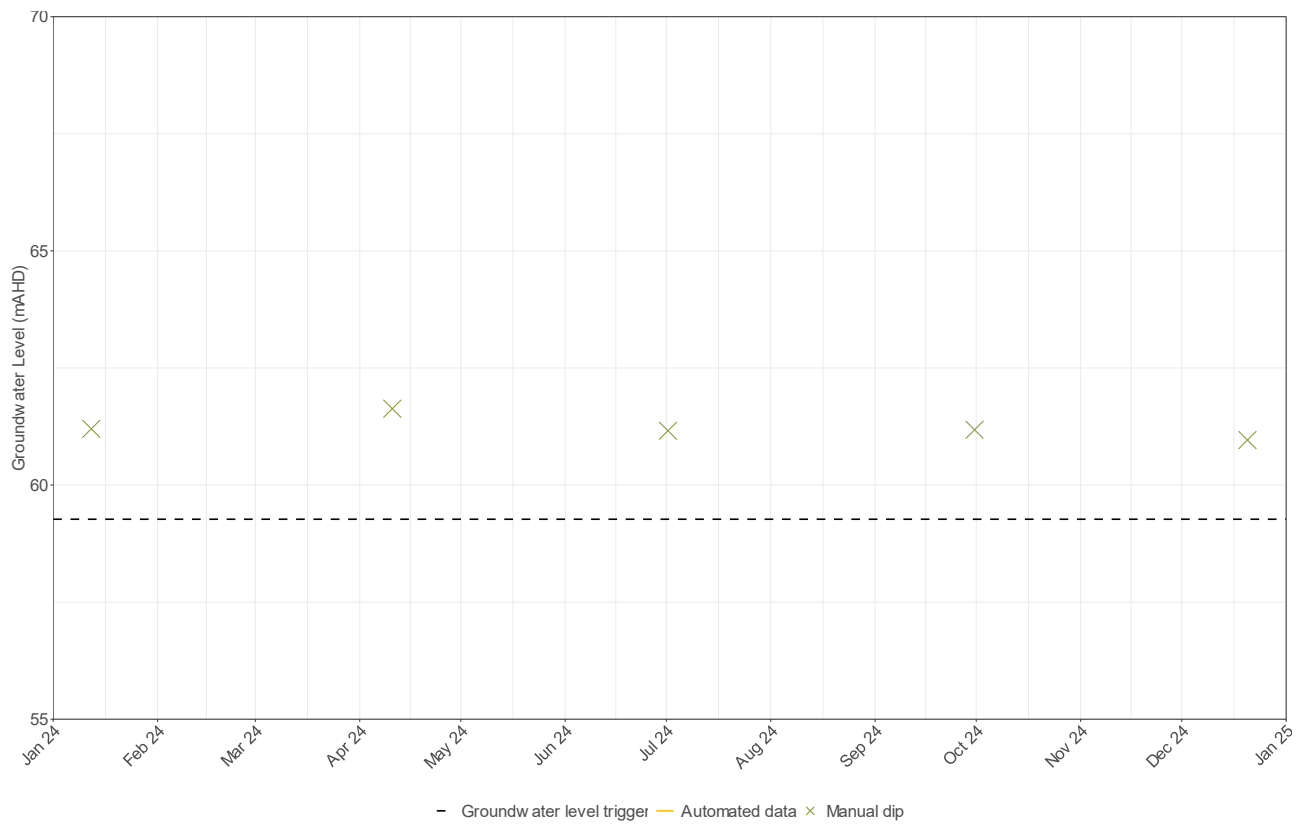
Figure 2 BH01_Shallow groundwater level hydrograph

³ In order to remove sampling induced drawdown, data has been filtered to remove interference.

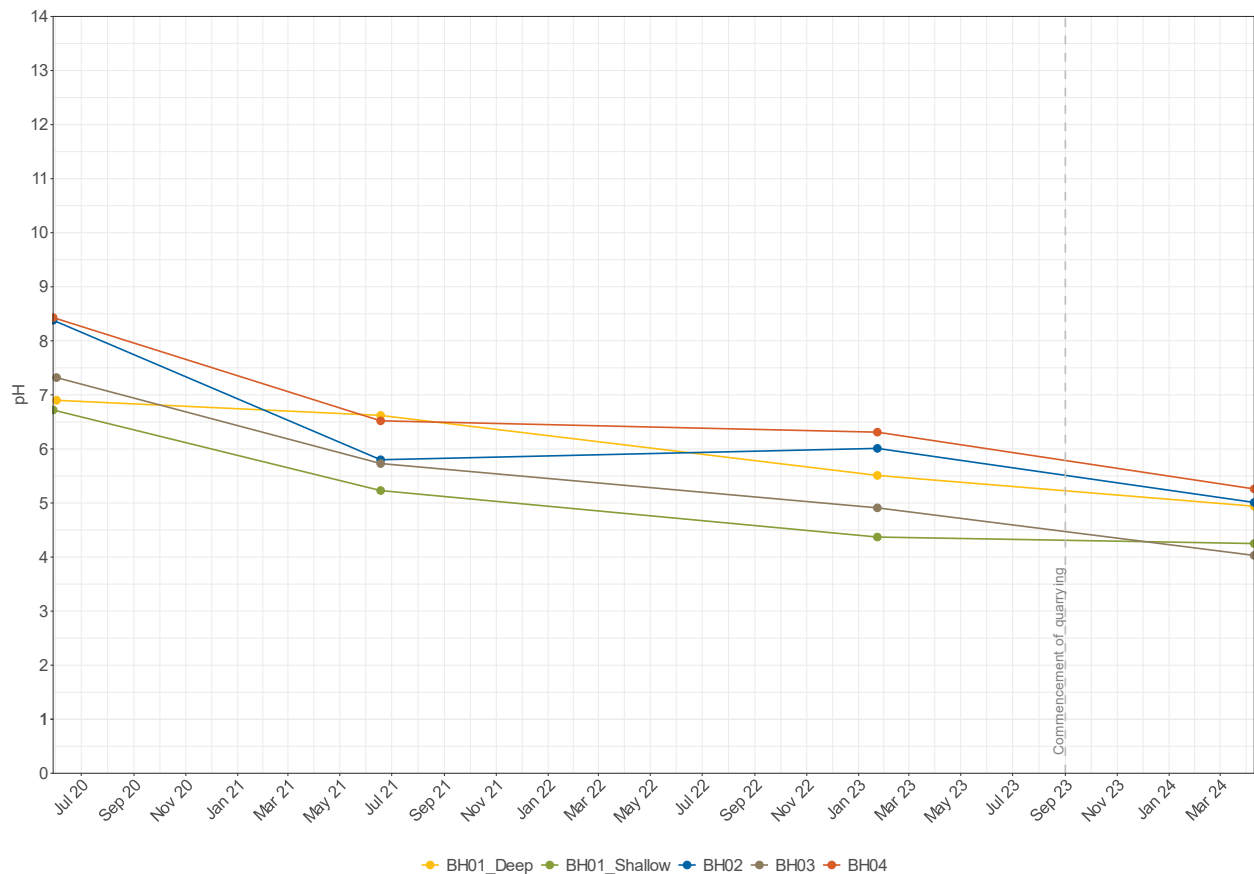
Figure 7 Historical groundwater monitoring pH results at Menangle Quarry

In accordance with the Trigger Action Response Plan (refer Table 6.6 of the SWMP) groundwater quality will continue to be assessed on an annual basis to determine a casual link (if any) with quarrying operations.

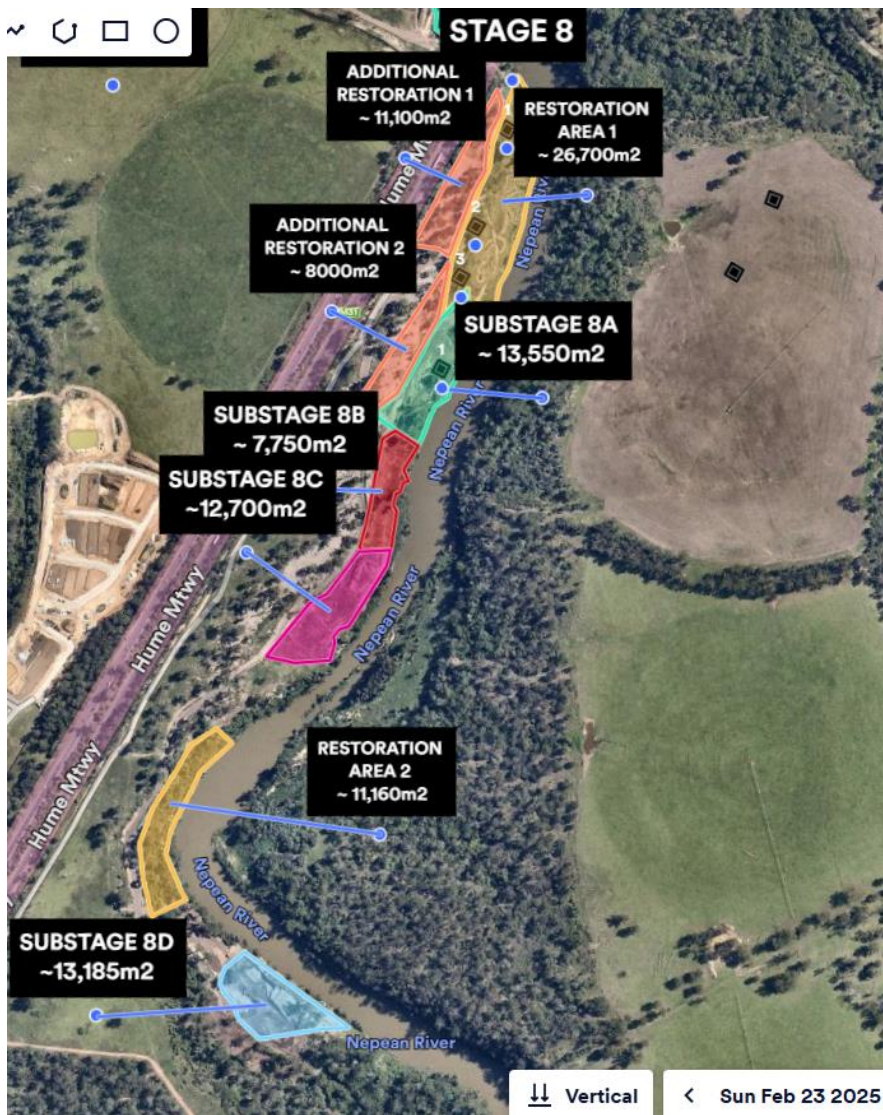
FIGURE 5. Stage 8 Restoration and Rehabilitation Areas at end 2024

MSS has restored additional areas in the Stage 8 area (see Figures 3,4 & 5) as part of its genuine commitment to successful rehabilitation of the extraction.

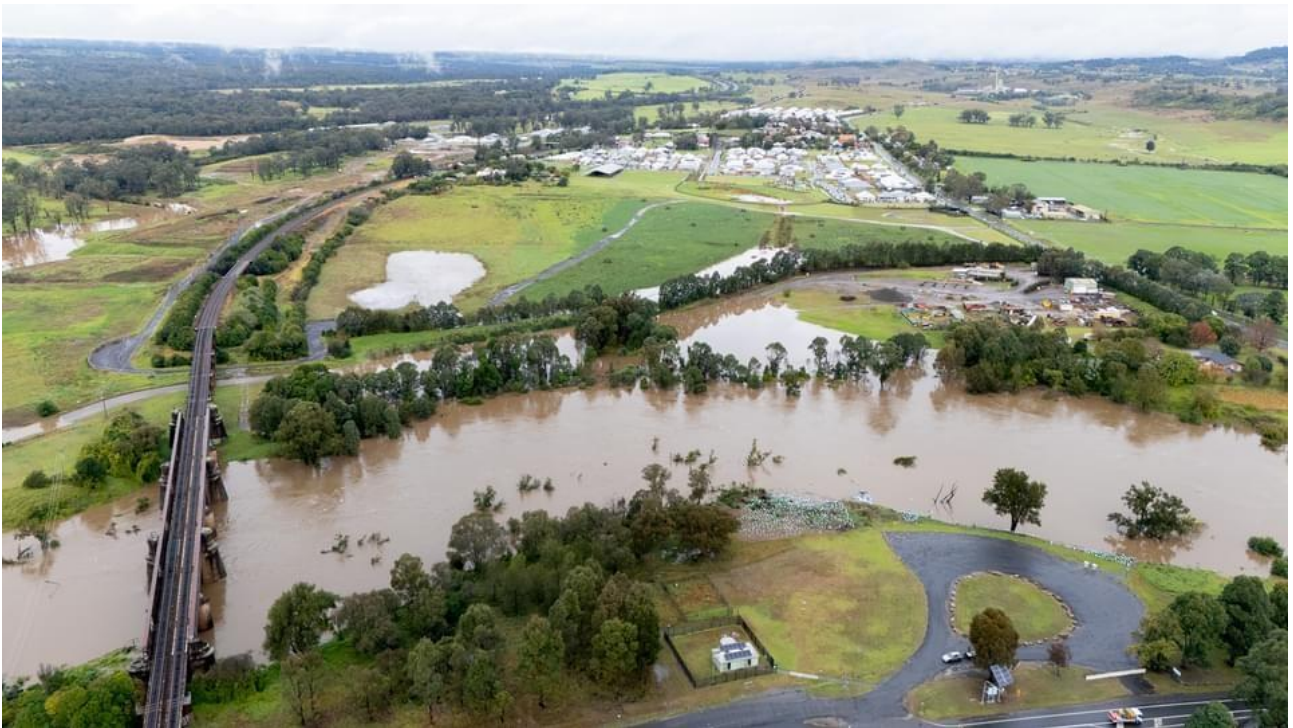
Photograph A.4 **Flooding in Stage 6 positioned opposite side of river**

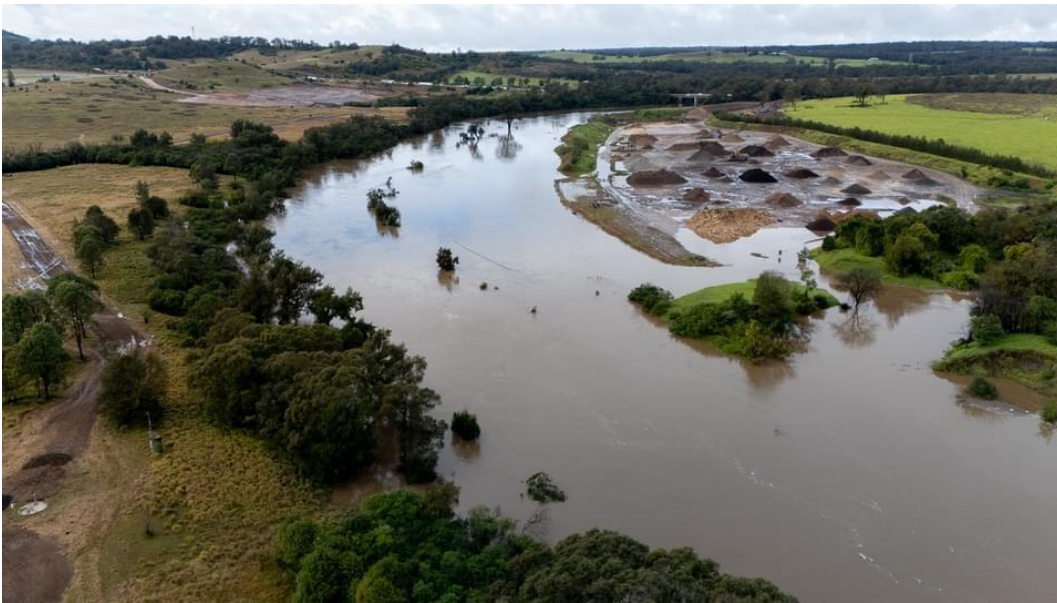
Photograph A.8 **Flooding in Stage 7 positioned opposite side of river, adjacent to non-vegetated area**

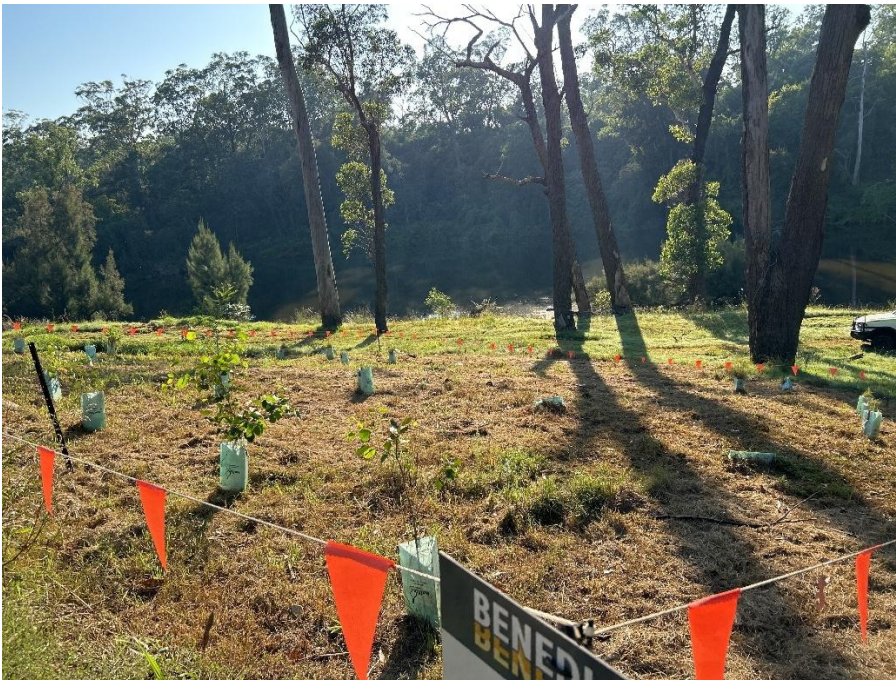
Photograph A.13 Plot R8.1 evidence of slashing >90% of rehabilitation plot

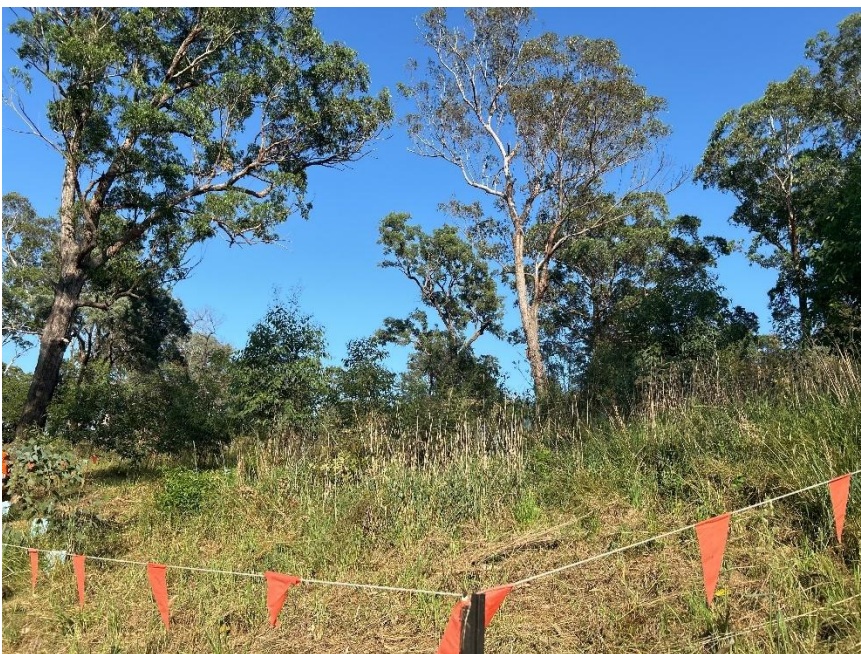
Photograph A.14 Plot R8.2 evidence of slashing >50% of rehabilitation plot

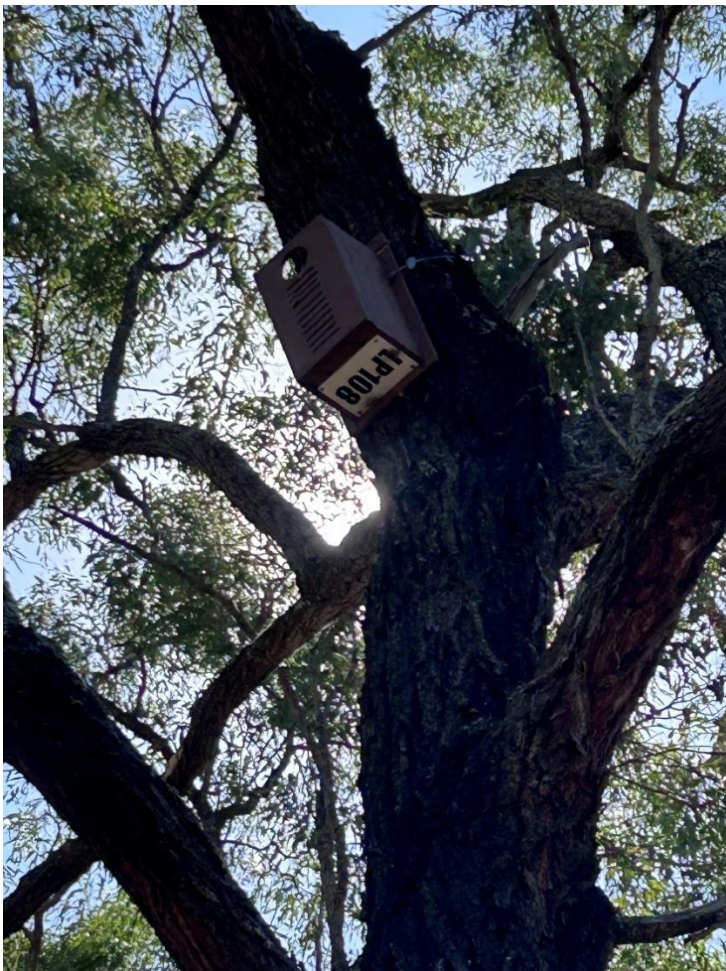
Photograph A.18 Nestbox LP108 requiring replacement

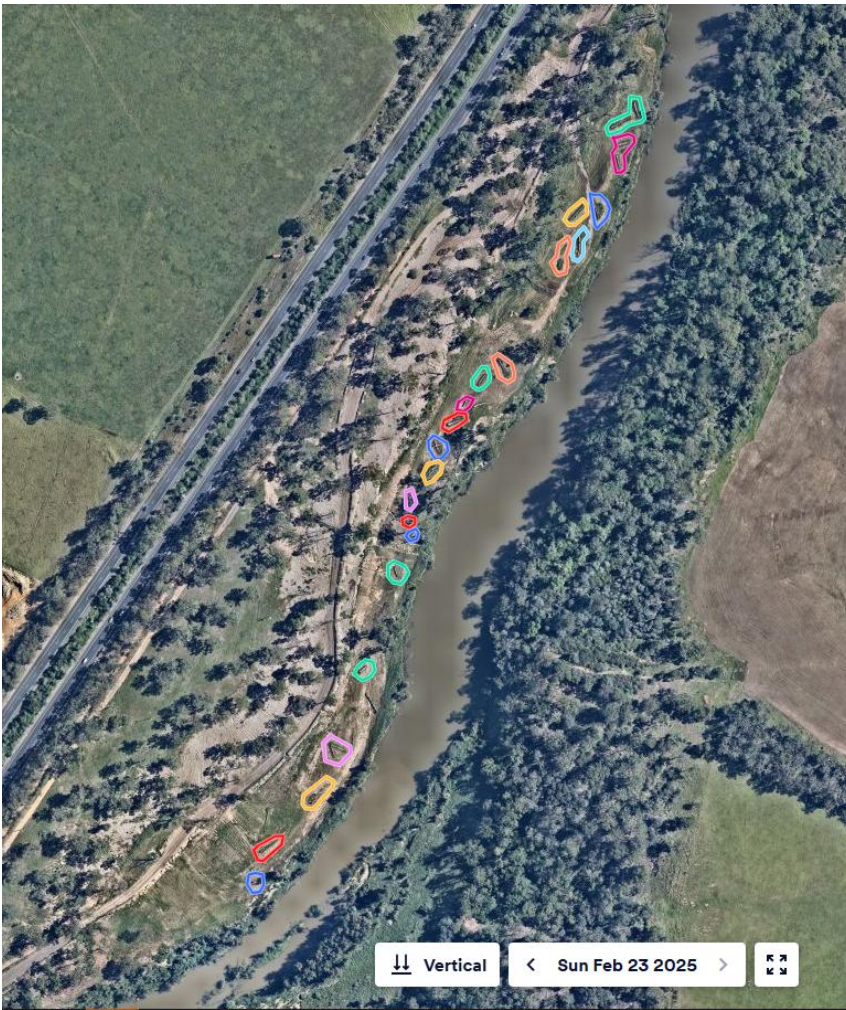
Photograph A.19 Location of large logs placed with associated long-stem tube stock planting (Photo supplied by Menangle Sand and Soil)

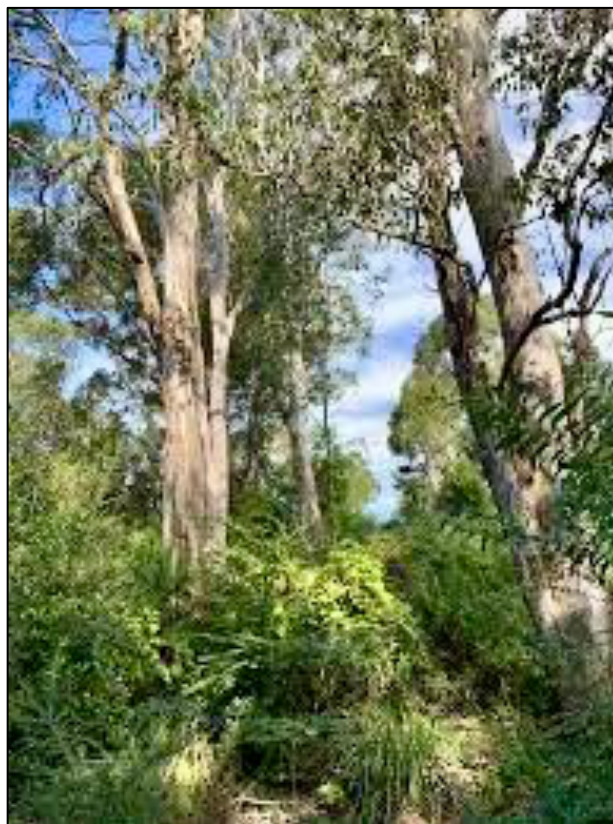
Figure1: Existing vegetation at Menangle Stage 8 - predominantly exotic weeds with a sparse occurrence of mature native trees.
