Subject: Condition B49 - Road Safety and Condit Audit

# **Menangle Quarry**

# **Road Safety and Condition Audit**

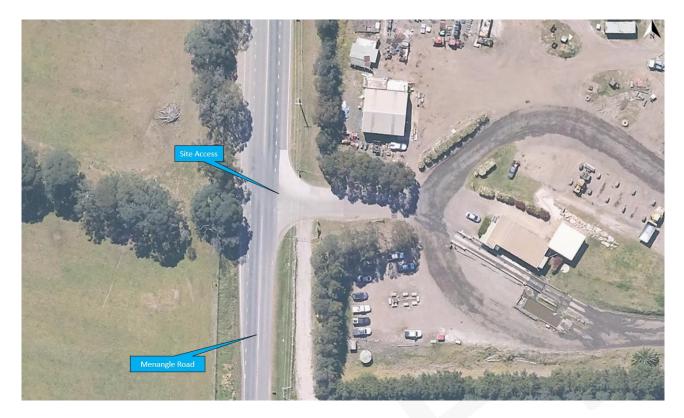
The vehicular access and egress to the site is provided by a single width driveway on Menangle Road, which is located approximately 700 m north of Woodbridge Road (Plate 3.2). At the site access, an approximately 85 m long deceleration lane is provided to the site driveway and 130 m Basic Right Turn (BAR) treatment is provided opposite to the site driveway.

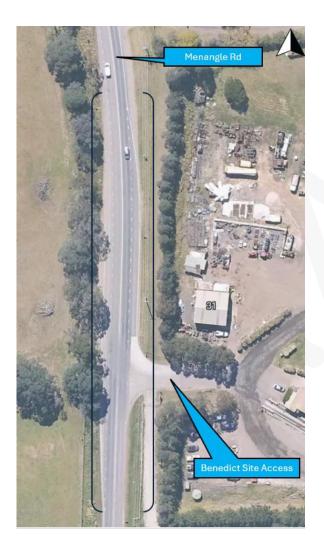
Figure 4.1 Road Safety and Condition Audit area

An approximately 180 m section of Menangle Road was inspected which is effectively from the beginning to the end of the BAR intersection treatment (Figure 4.1). This section of Menangle Road is considered to be a sufficient length to comply with the relevant condition for the Road Safety and Condition Audit.

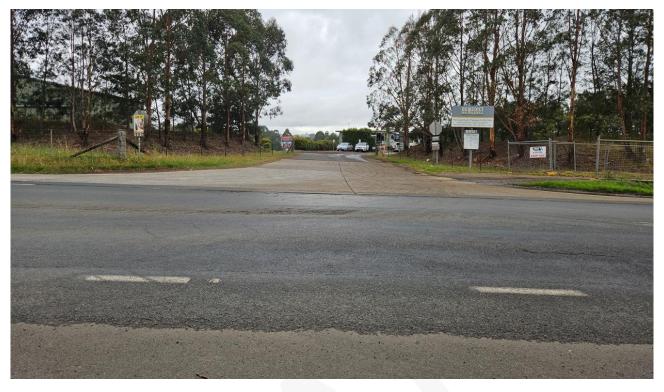
#### Plate 4.1 Menangle Road/Benedict Access intersection

The site access on Menangle Road has a large intersection geometry which facilitates turning movements by large trucks without any difficulty. At this intersection, the northern approach is wider which accommodates four travel

lanes (approximately 13.5 m wide). The southern approach is approximately 9.5 m wide which accommodates three travel lanes. The site access driveway is approximately 9.5 m to 10 m wide (Plate 4.1).

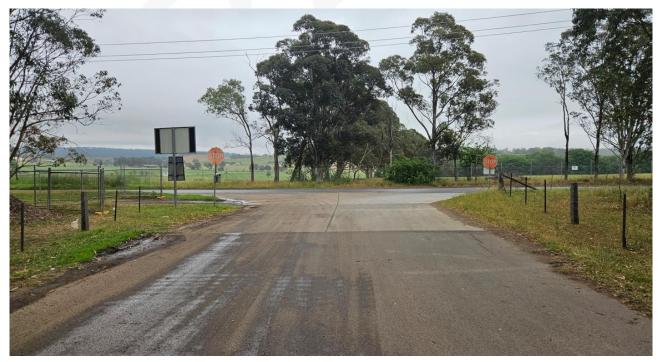
The site access is currently priority controlled, with Stop signs provided on both primary and secondary sides (Plate 4.2). The Stop signs are slightly faded and could be replaced by new signs. There is no stop line marking (TF) for outgoing trucks at the site access.

The faded Stop signs should also be replaced by new signs (Plate 4.2).

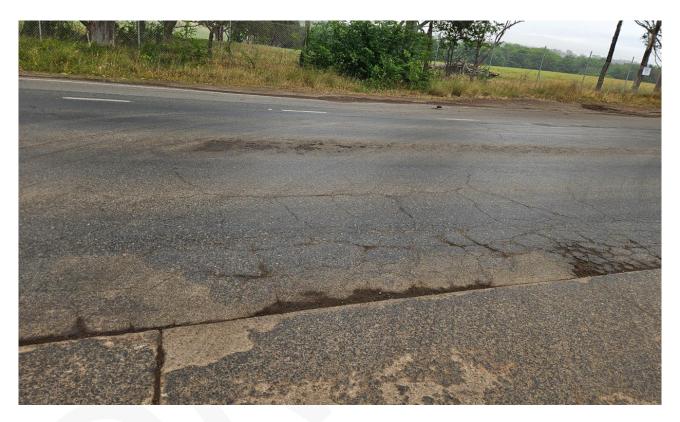
During the inspection, the road pavement condition on Menangle Road at and near this intersection was generally found to be in good condition. However, there were some hairline cracks and small potholes on observed on Menangle Road just outside the site access driveway, possibly due to the wear and tear from turning trucks at this intersection (Plate 4.3).

#### Plate 4.3 Pavement cracks on Menangle Road at the site access

Although the pavement cracks do not cause any immediate concern, over time, with rain and continuous turning truck traffic, these cracks will allow water to penetrate into the pavement subbase and subgrade layers which could be expensive to repair.

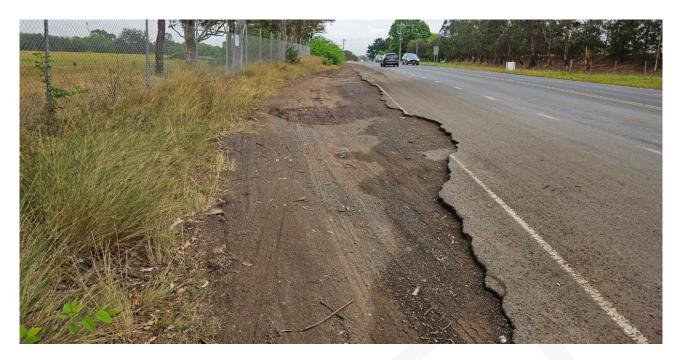
Directly opposite to the site access, the edge of the pavement was observed to be broken, possibly due to trucks driving or parking over the unsealed shoulder at this location which is evident by the tire marks (Plate 4.4). Drivers are encouraged not to stop in that area, however, it is difficult to stop as this area is also used by public vehicles for stopping and parking.

Plate 4.4 Edge of pavement is breaking up at opposite side of the Benedict site access

As the pavement edge breaking has encroached onto the existing travel lane, this should be repaired as soon as practicable.

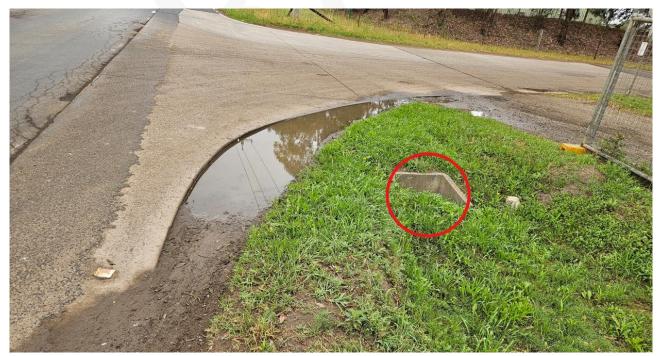
Water ponding occurs at the left-hand side edge of the driveway. This is possibly due to the existing culvert not draining properly (Plate 4.5). The cause of this situation needs to be inspected by a drainage engineer and repair work should be undertaken as soon as practicable.

The observed pavement damage and water ponding issues at or near to the site access driveway intersection need to be repaired/upgraded in accordance with the Council's <u>Design</u> and <u>Construction</u> specifications. Council's standard drawings can be found <u>here</u>.

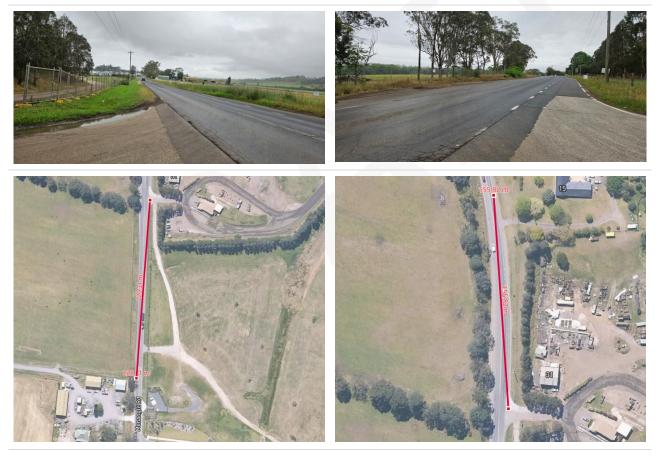
The posted speed limit on Menangle Road is 60 km/h. For the relevant 70 km/h intersection design speed (60 +10), a minimum 151 m sight distance is required from the Benedict site access to approaching traffic in each direction along Menangle Road for the standard 2 seconds driver's reaction time. The site access is located at a reasonably straight geometry along Menangle Road so sufficient sight distances are available to the left and right as shown in (Figure 4.2).

Sight distance to the left (220 m+)

Sight distance to the right (155 m+)

During the site inspection it was noted that truck drivers have a better visibility of approaching traffic due to the additional height and they were all observed to exit the site in a safe manner. Therefore, there are no geometric design road safety issues at the site access intersection. Furthermore, TfNSW's Centre for Road Safety crash statistics do not show any recorded crash at this intersection.

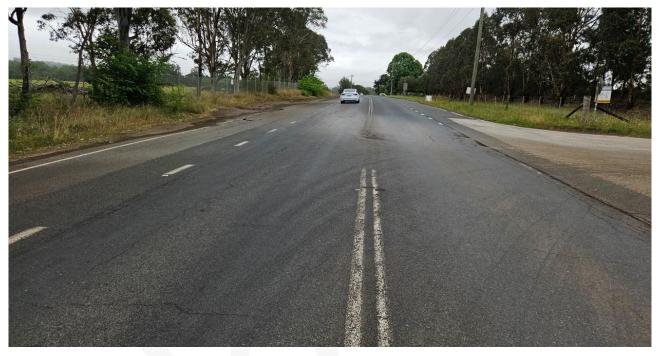
As stated earlier there is no existing stop line marking at the site access on Menangle Road. Furthermore, due to the frequent truck turning movements, some of the major road line marking was found to be faded and reflective pavement markers (RRPM) are missing (Plate 4.6).

Plate 4.6 Faded line marking and missing pavement markers on Menangle Road

It is recommended that upon repair of the pavement, the line marking at this site access is to be redone for the site inspection area shown in Figure 4.1, along with an additional stop line provided at the driveway exit (Figure 4.3).

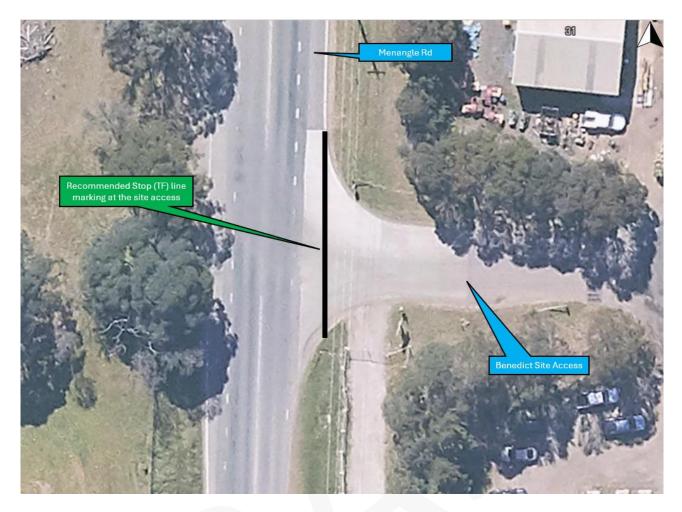
Figure 4.3 Recommended Stop line at the Benedict driveway exit on Menangle Road

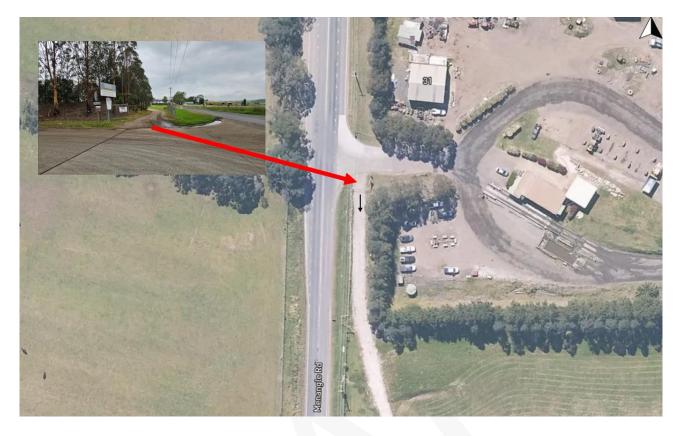
Figure 4.4 Travel path parallel to Menangle Road

During the site inspection a number of vehicles were observed to enter a vehicle access path parallel to Menangle Road to the south of the site access driveway (Figure 4.4). These vehicles were associated with the residential construction in areas south of the quarry.
