# Flood Management Plan

Menangle Sand and Soil Quarry

Prepared for Menangle Sand and Soil Pty Ltd February 2022

J190166 RP28

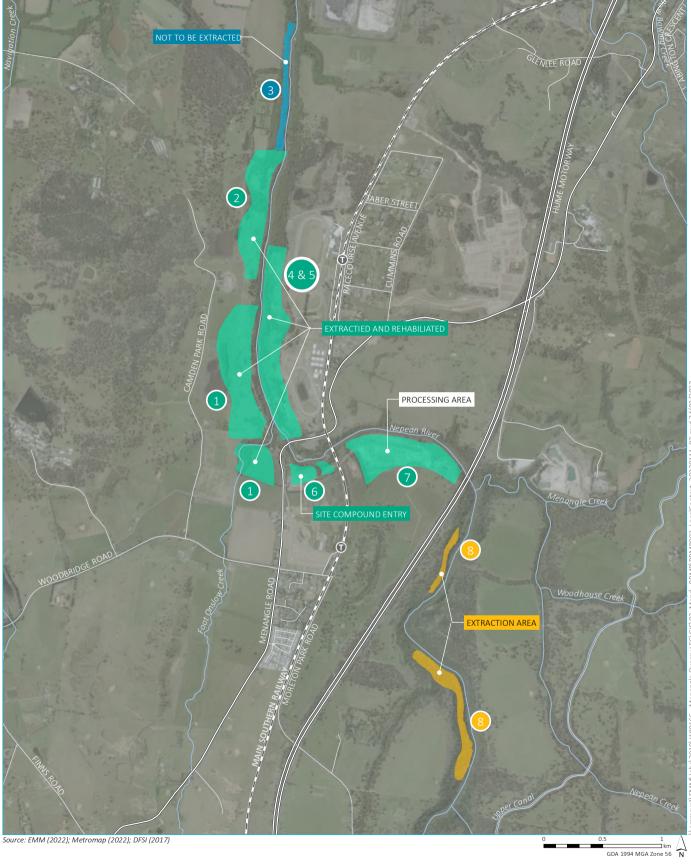
Menangle Sand and Soil Quarry Figure 1.2

Menangle Quarry stages 1 to 8

To date, sand and soil has been extracted from Stages 1 to 2 and 4 to 7 (Figure 1.2). While previously approved, sand and soil will not be extracted from Stage 3.

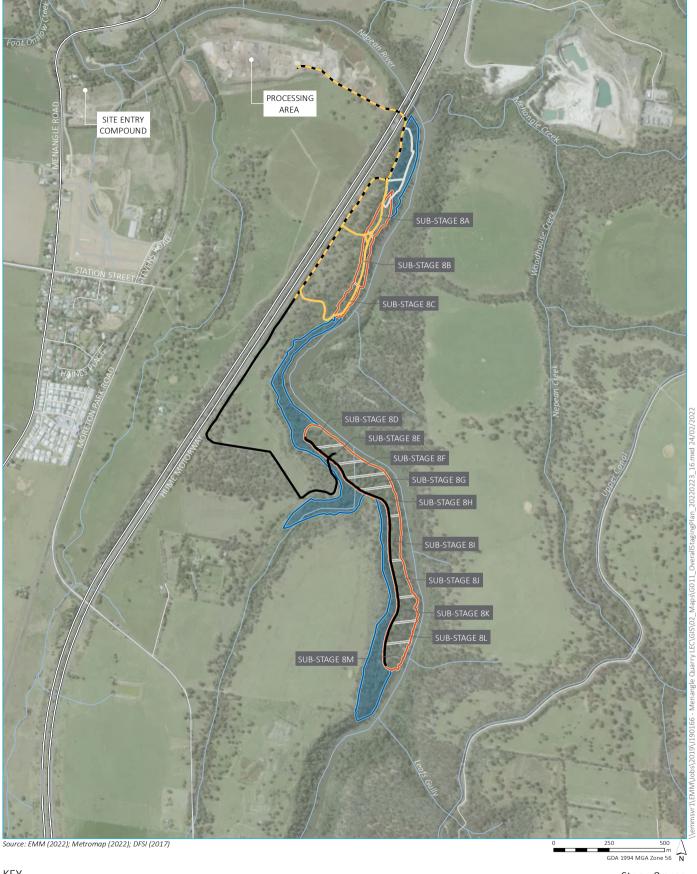
Menangle Sand and Soil Quarry Figure 1.3

Phase 1 Sub-stages 8A - 8B Phase 2 Sub-stages 8C Phase 3 Sub-stages 8D - 8E

Phase 4 Sub-stages 8F - 8G Phase 5 Sub-stages 8H - 8I

Phase 6 Sub-stages 8J - 8K Phase 7 Sub-stages 8L - 8M Stage 8 area

The quarry has consent to extract the sand and soil resource in the Stage 8 area to 2035. Stage 8 has been split up into 15 sub-stages (Figure 1.3) which have been further categorised into seven extraction phases (Table 1.1).

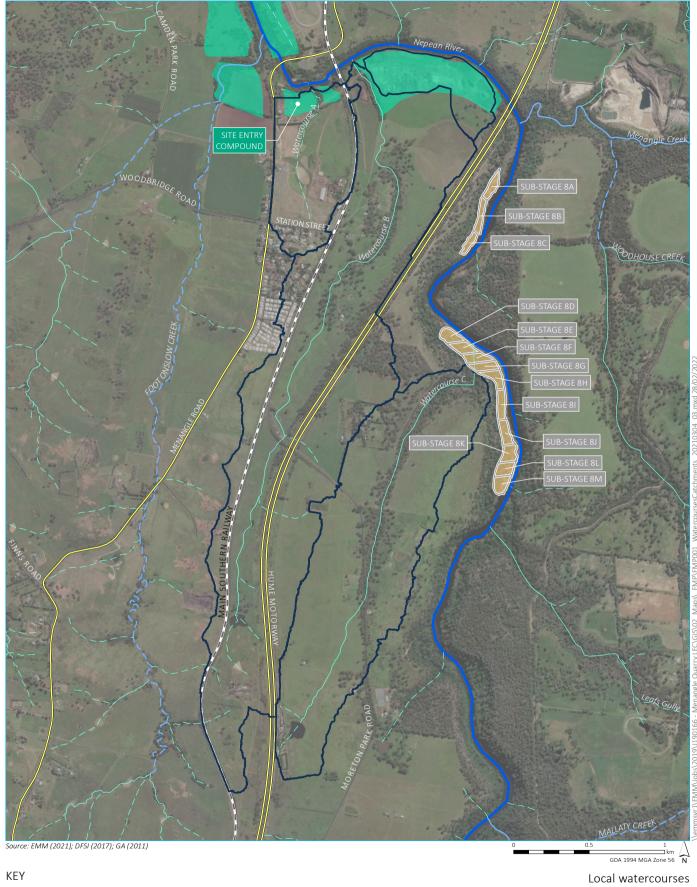
Substage boundary

Stage 8 - extraction/rehabilitation area

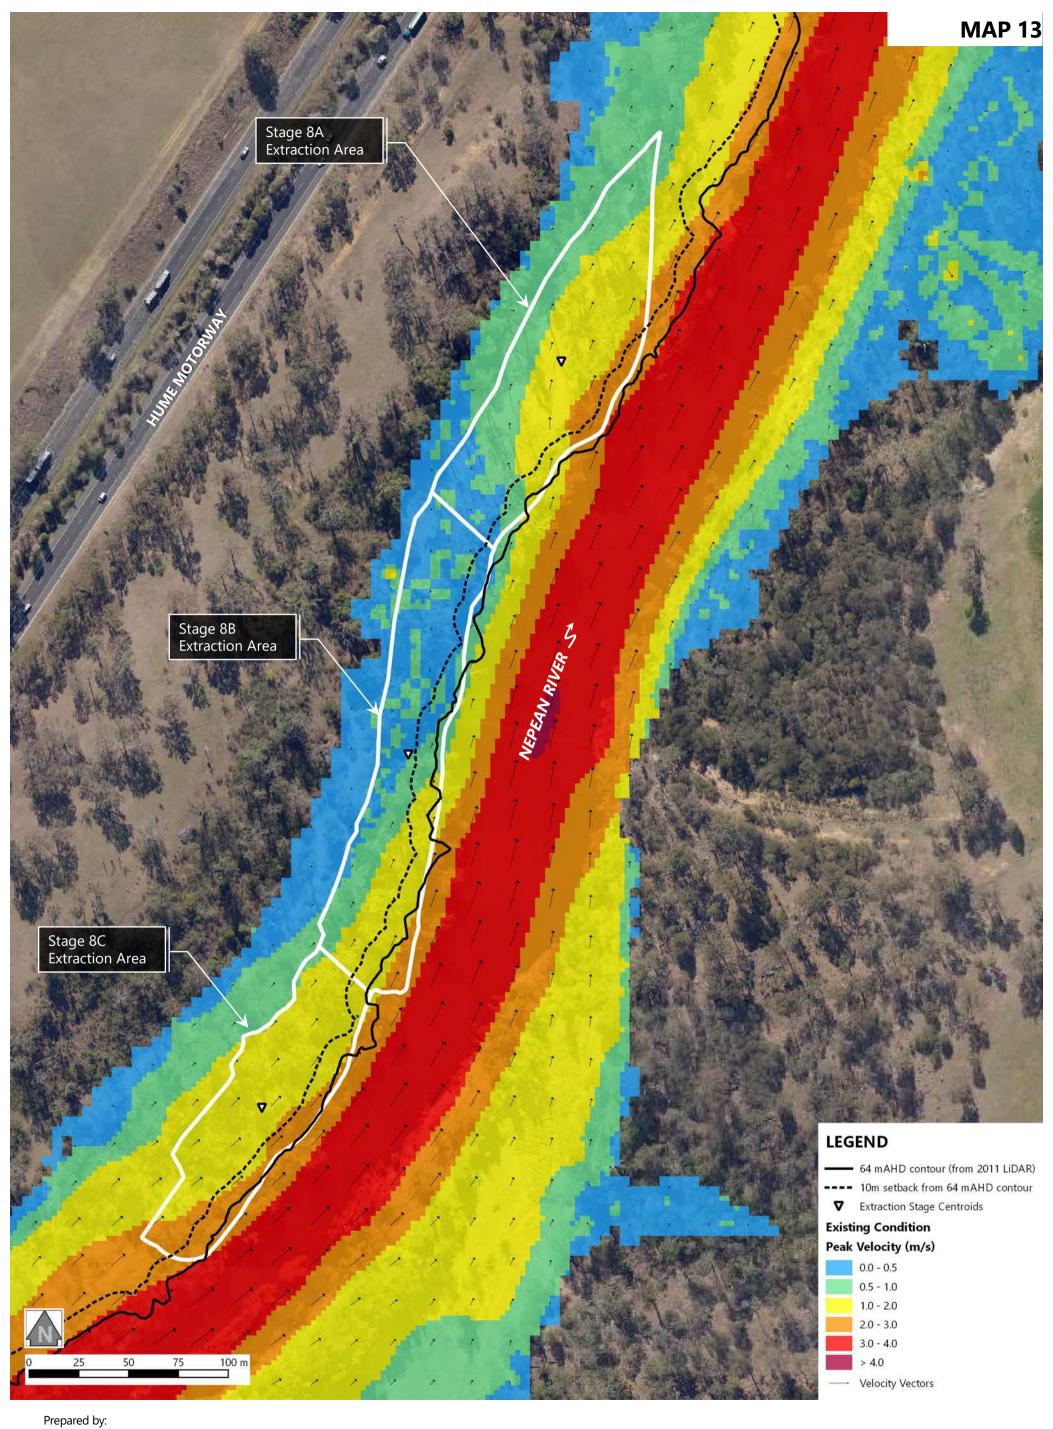
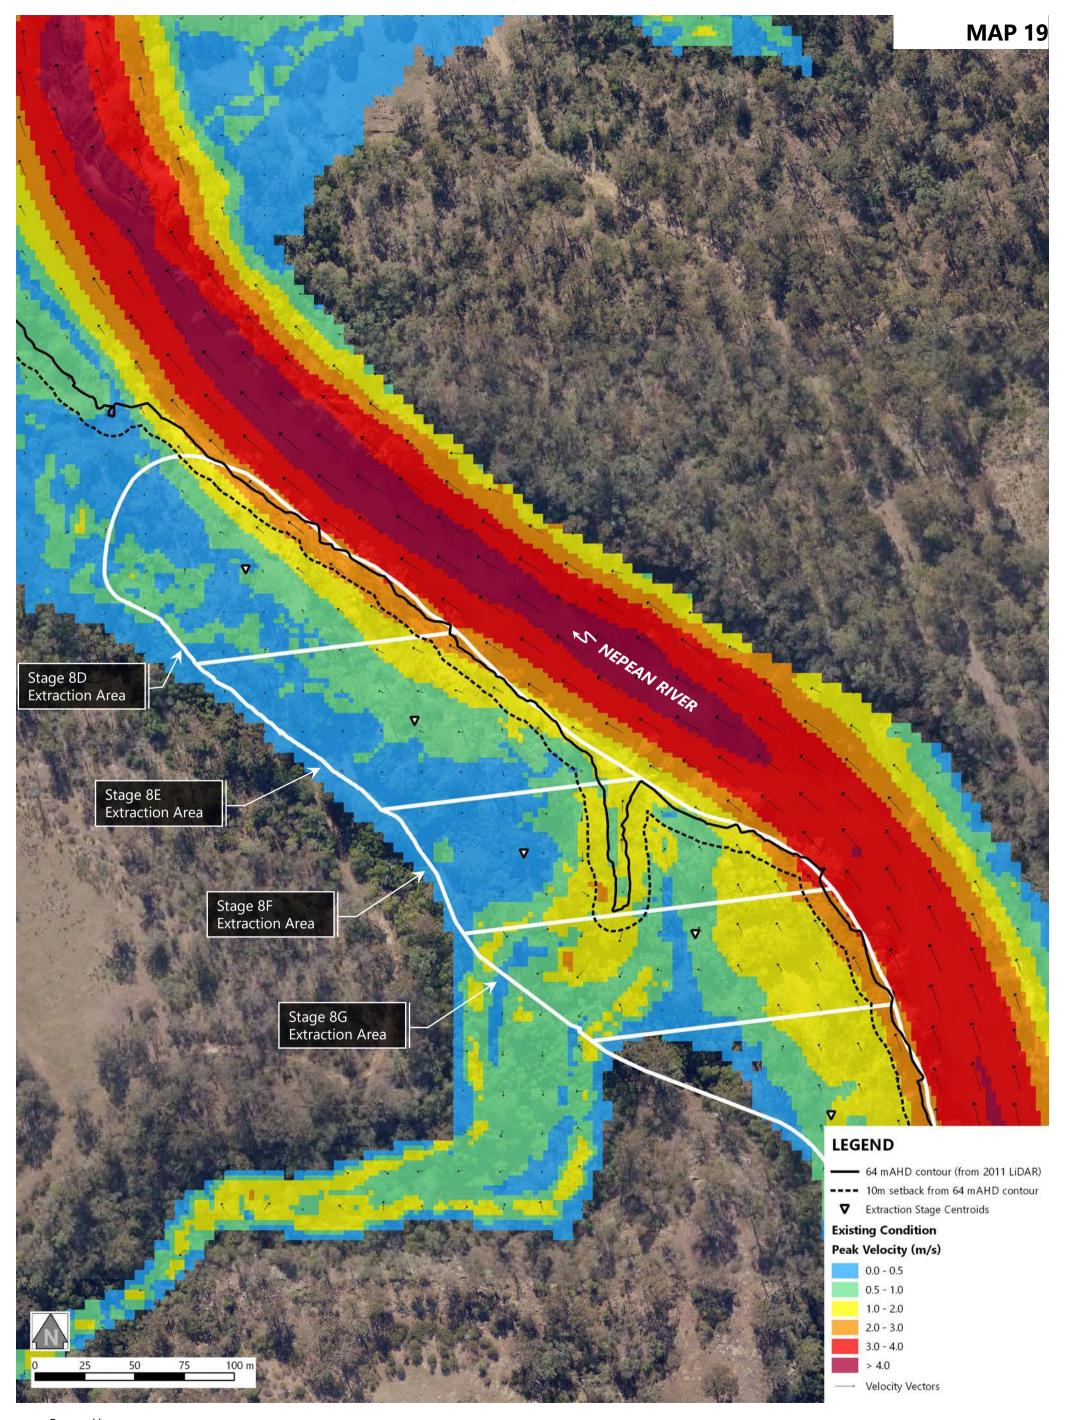
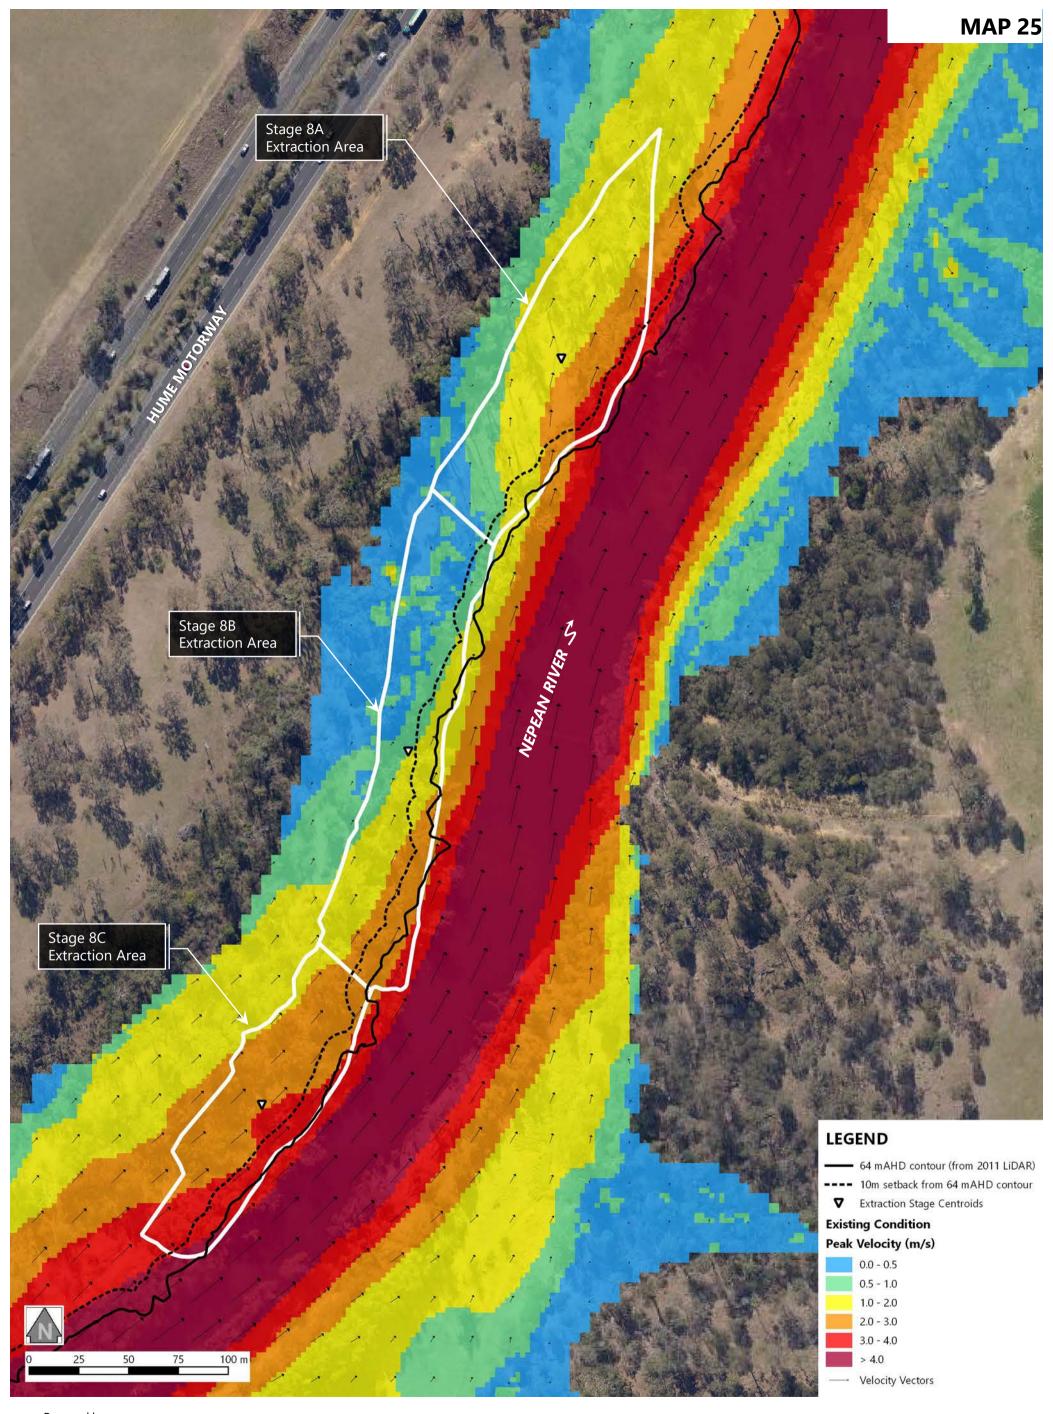
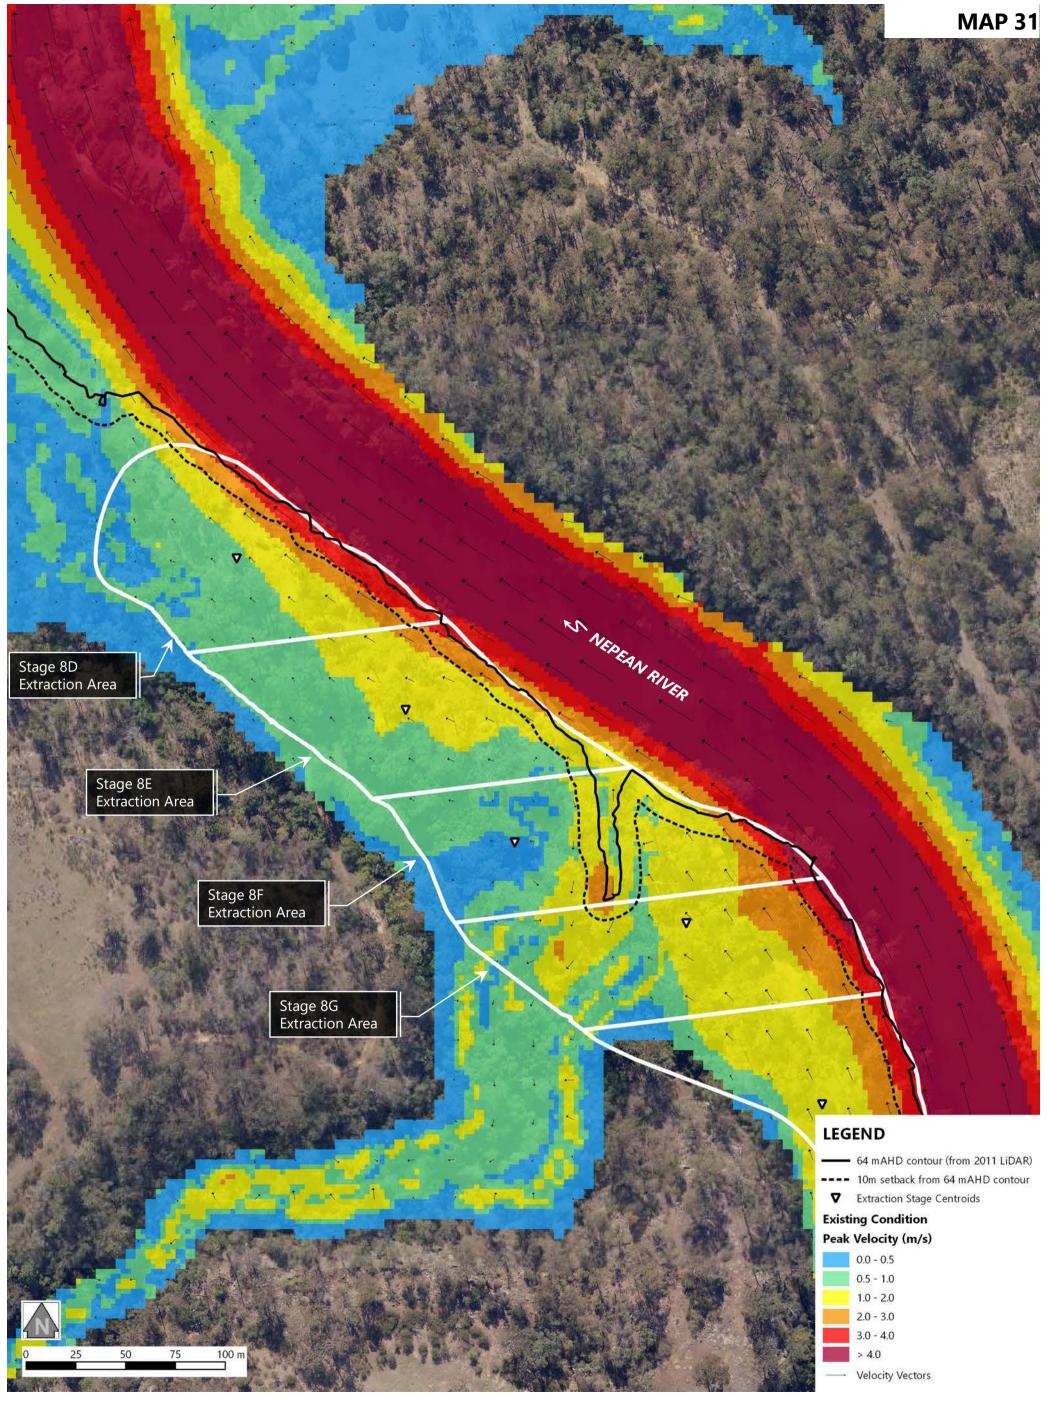
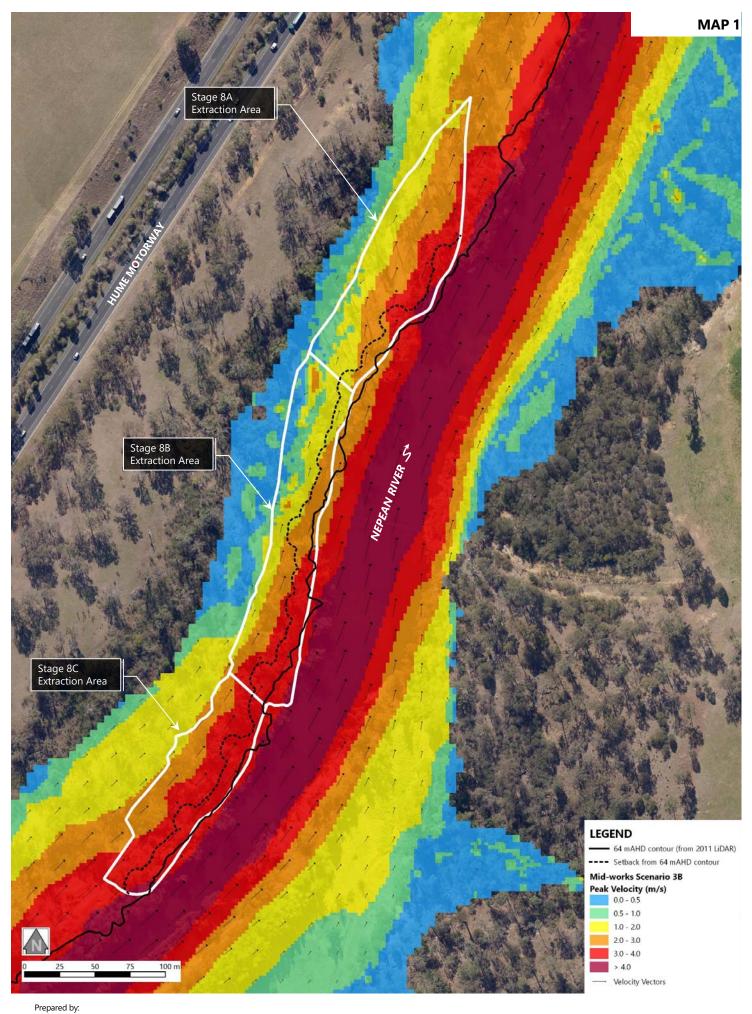
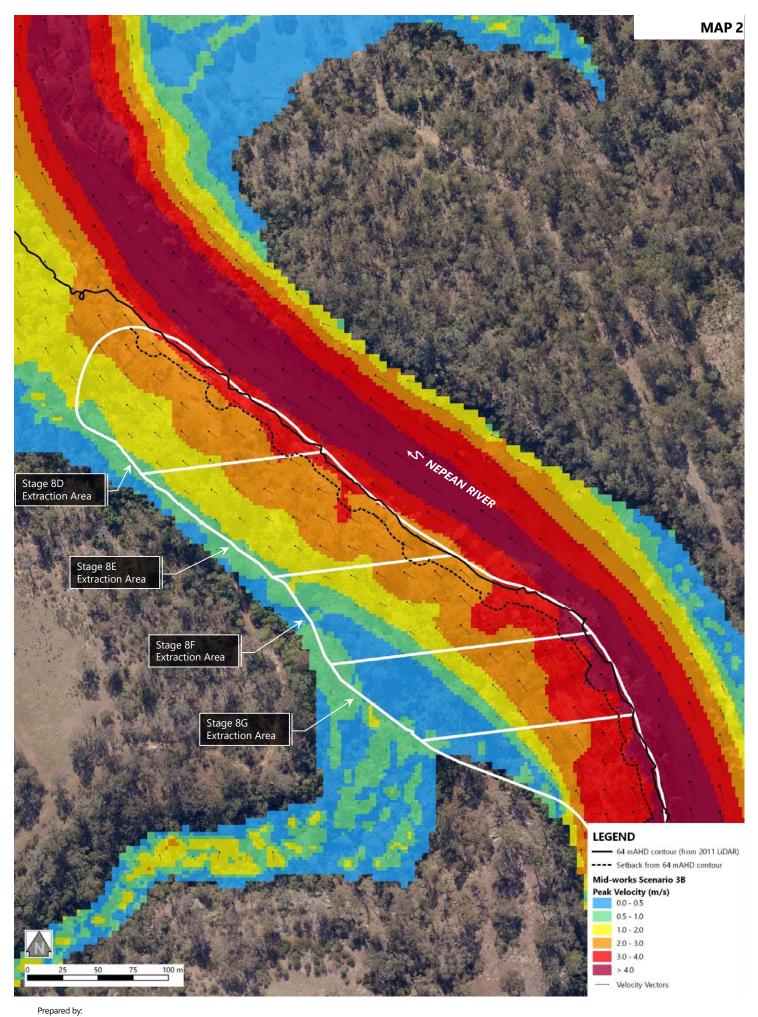
# Flood mapping – Stage 8 extraction areas

The TUFLOW hydrodynamic model used to inform the *Flood Impact Sensitivity Assessment* (Advisian 2019) was modified by Advisian in December 2020 to assess the post extraction topography for all substages using hydraulic roughness Scenario B as per Consent Condition A14. The resulting 1% annual exceedance probability (AEP) flood results for substages 8A–8C, 8D–8G and 8H–8M are provided in Appendix D along with existing conditions flood mapping.
